Weaselhead/Glenmore Park
Southwest Calgary Ring Road Environmental Impact Study 2016-2022

Final Report

Environmental Impacts from the Southwest Calgary Ring Road Project
on the Weaselhead Special Protection Natural Area:
Field Studies from 2016 through 2022 with Interpretations and
Recommendations

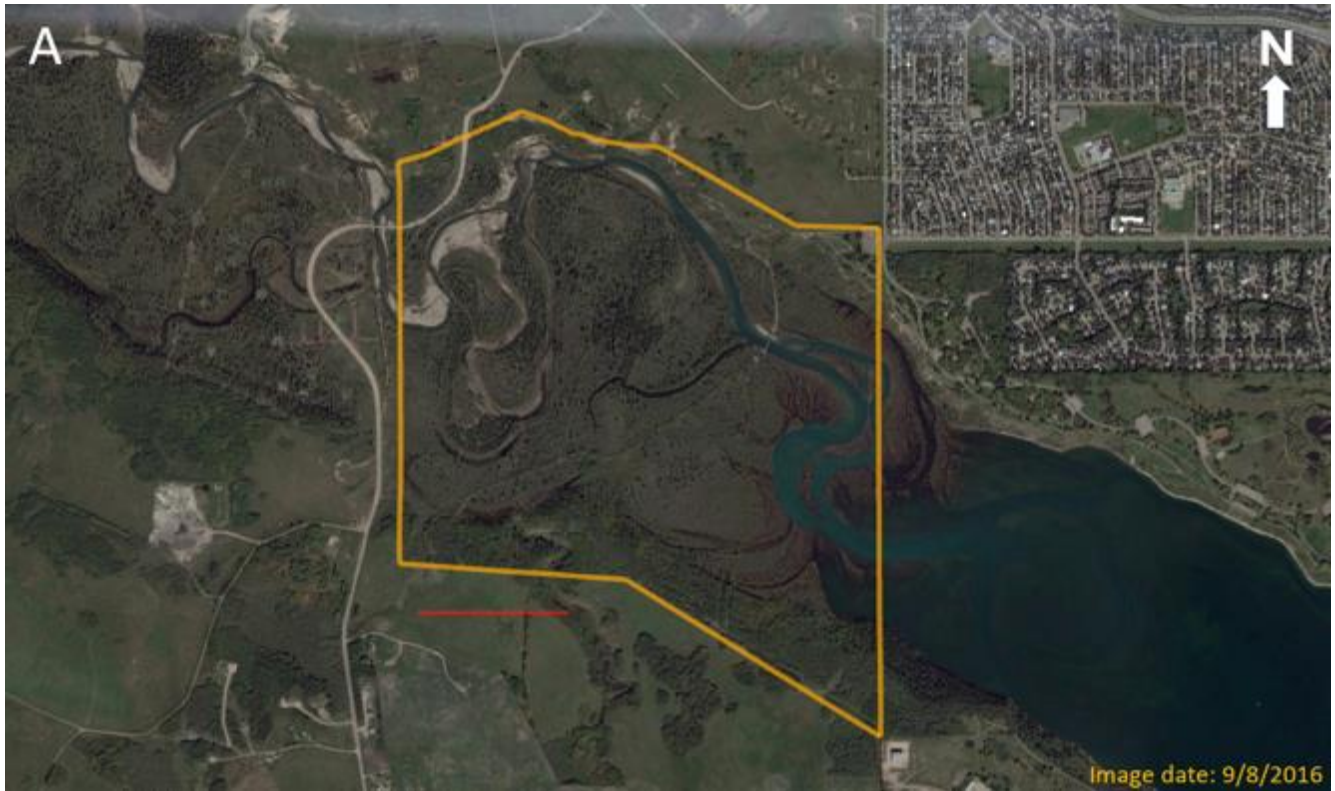
Figure 1A. An aerial image of the Weaselhead, September 8, 2016, before major construction of the SWCRR began. (Weaselhead boundary: orange line; Red line = 500 m scale, *Google Earth*)

Aerial images of the Weaselhead and Transportation Utility Corridor (TUC) in 2016 before construction started (Figure 1A) and the same area in June 2022 (Figure 1B) after the opening of the section of the SWCRR adjacent to the Weaselhead are below. Important site locations and their names referenced throughout this document can be found in Figure 1C. A timeline of construction events and sediment mitigation failures can be found in Figure 1D.

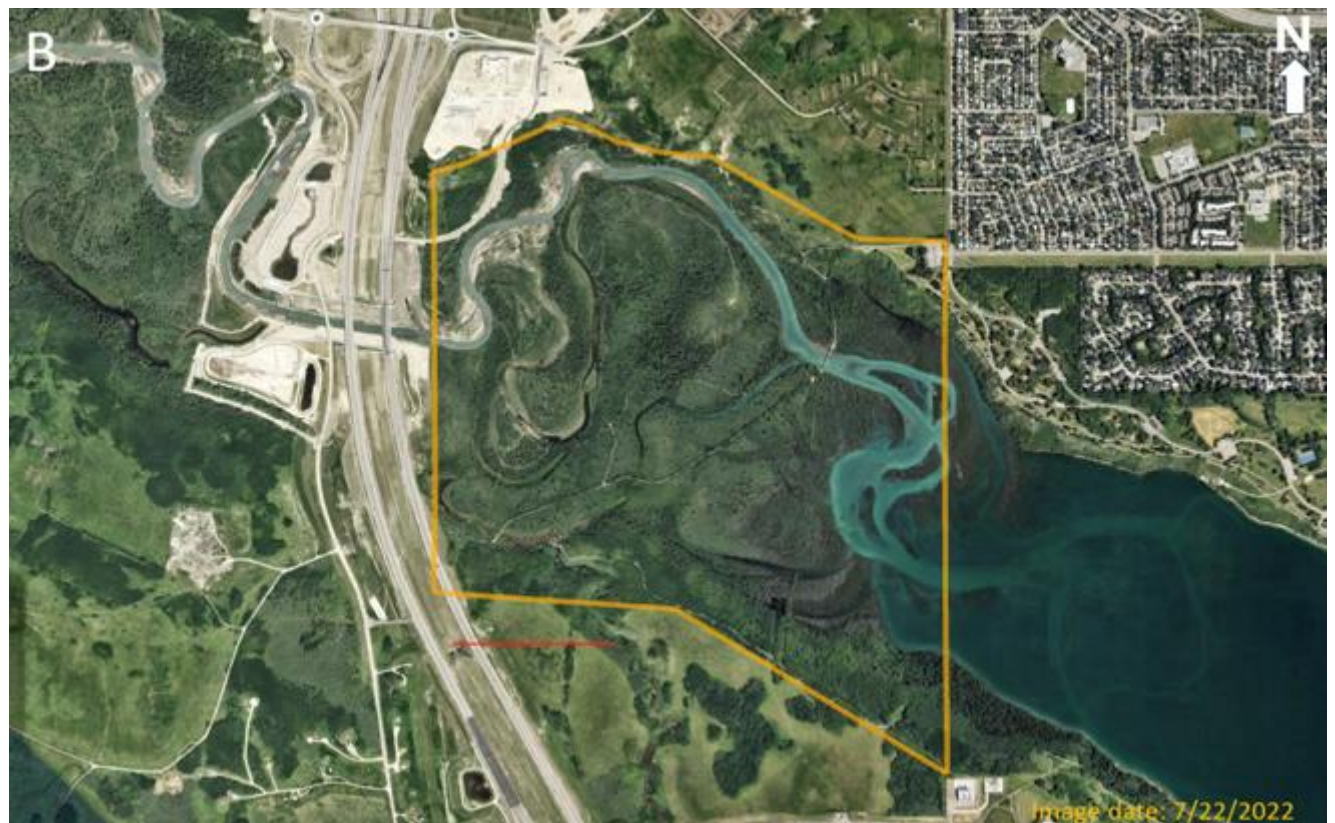
Figure 1B. An aerial photo of the Weaselhead on July 22, 2022, with the SWCRR project complete. (Weaselhead boundary; orange line; Red line = 500 m scale; *Google Earth*).

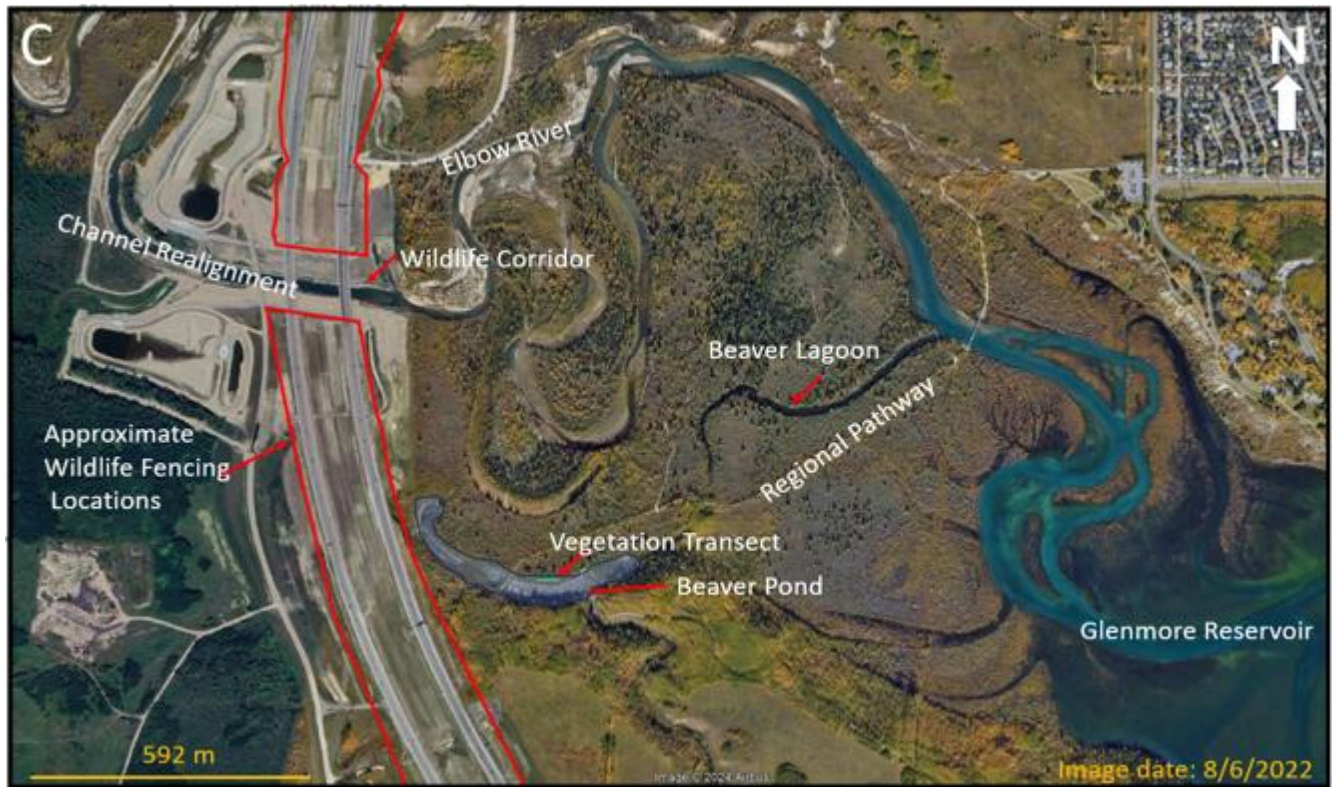
Figure 1C. Aerial image of the Weaselhead showing key Study locations by name. The upstream reference wetland sampling location used in the Study is outside the region shown in this map. (Google Earth; August 6, 2022)

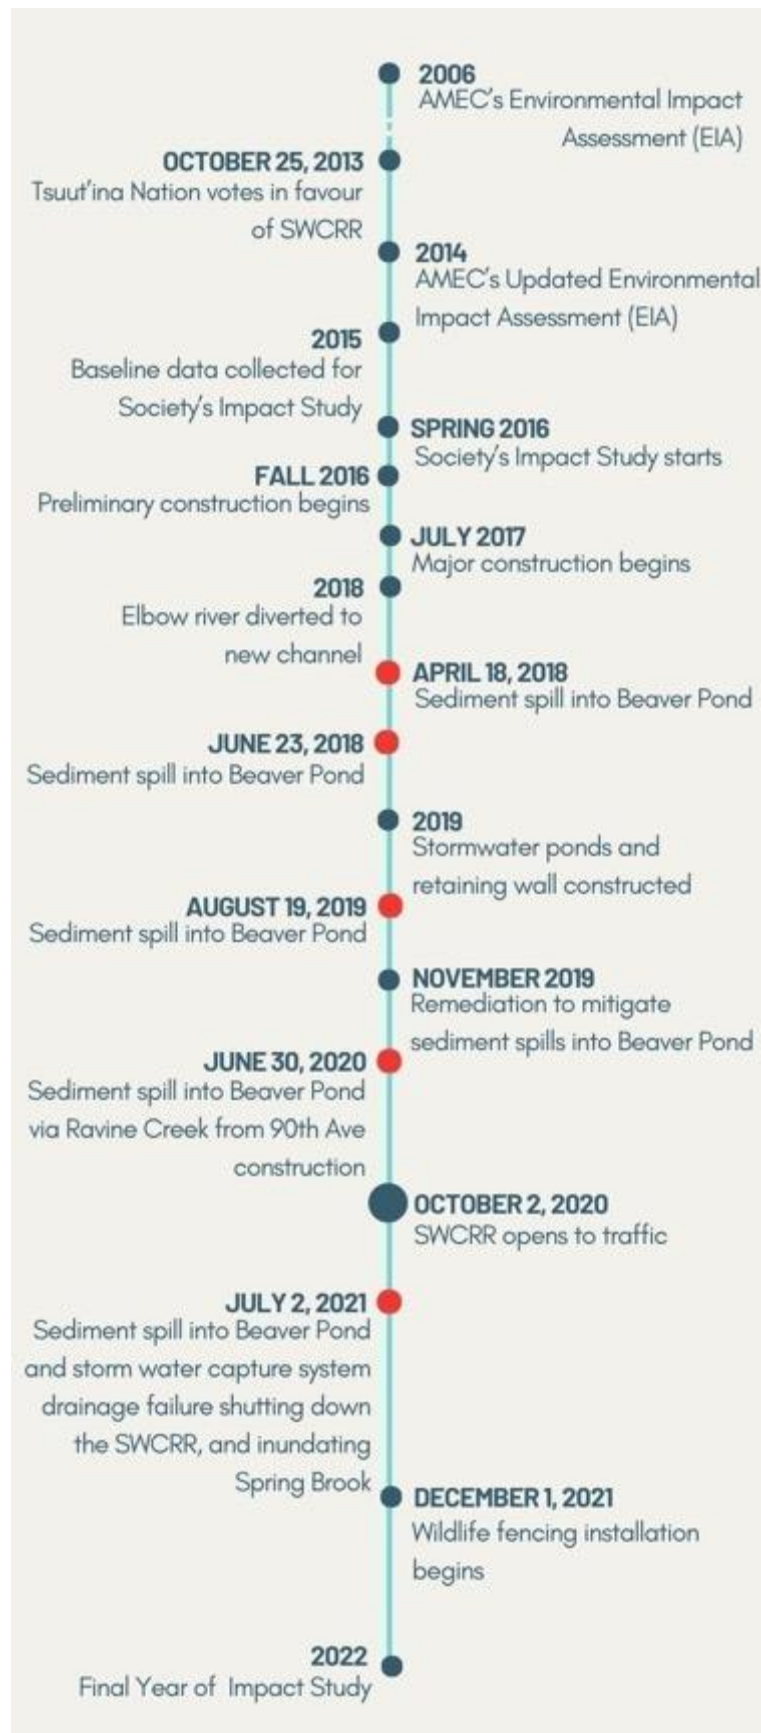
Figure 1D. Construction and sediment spill timeline (timeline not to scale). The dates of sediment slides resulting from failed mitigation efforts impacting the Beaver Pond are highlighted with a red dot.

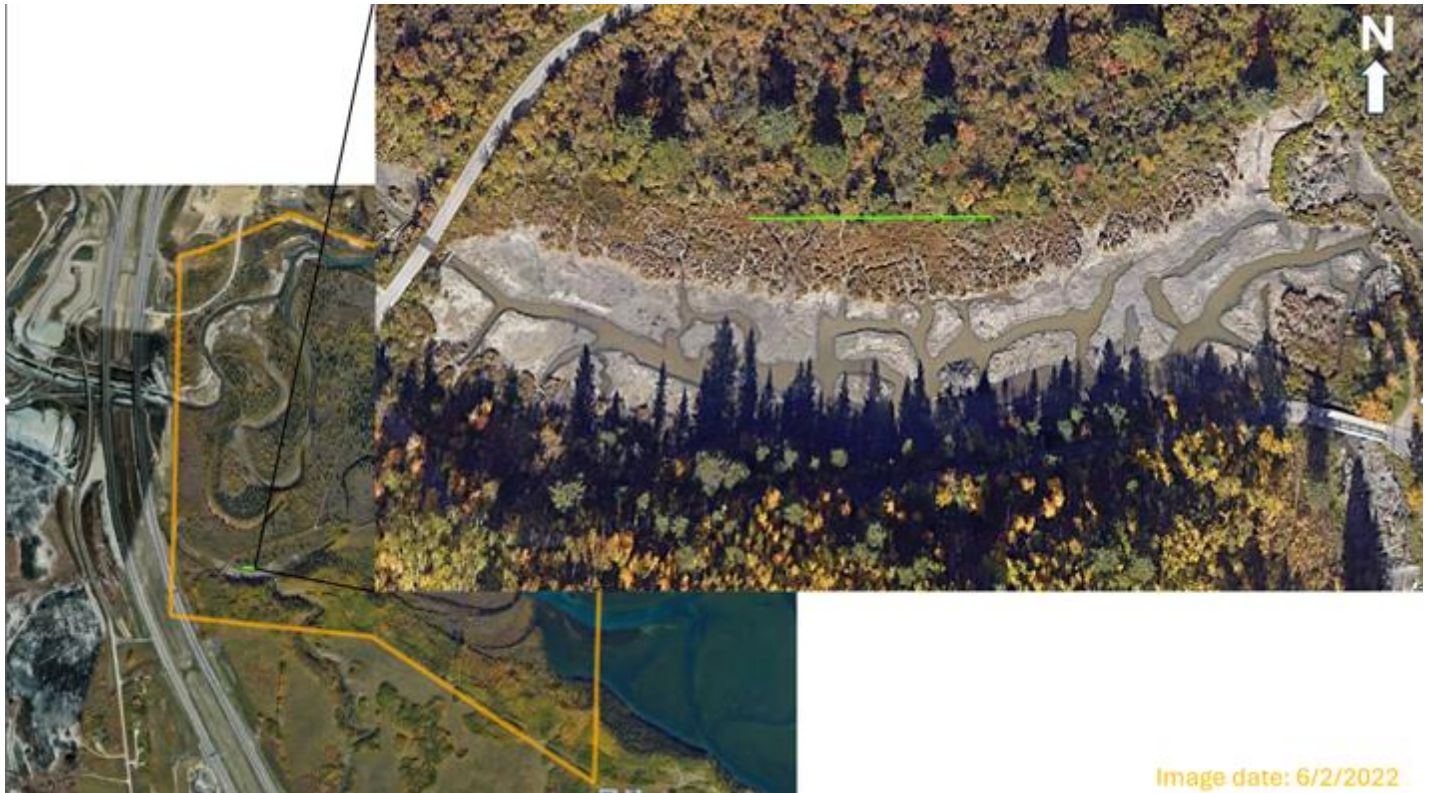
Figure 2. Green line of the inset shows the location of the 50 m transect used for vegetation survey on the north bank of the east Beaver Pond. The orange line indicates the Weaselhead boundary. (*Google Earth*, June 2, 2022).

The Society's Study collected data on species composition, diversity, and species richness within a consistent transect location found along a wetland immediately adjacent to SWCRR construction. Baseline information was collected in 2015 and 2016 to describe the riparian vegetation by the Beaver Pond in the Weaselhead. This wetland was chosen as its upstream edge is bordered by the SWCRR and represents riparian habitat in immediate proximity to the SWCRR (Figure 2). The same site was used in all studies from 2015 to 2022³.

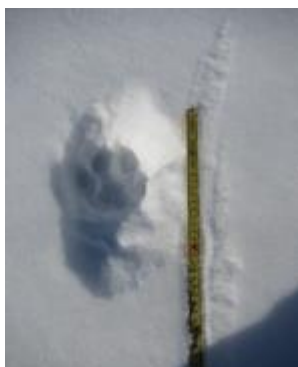
Figure 5. Cougar track observed in bend of Elbow River realignment in the buffer zone, January 2020. (KGL, Monthly Wildlife Report³¹).

The wildlife reports showed that over the construction period cougar (*Puma concolor*) would enter the buffer regions, but there was no evidence of the cougar traveling under the bridges through the intended corridor (Figure 5)³¹. However, the implemented design is a significant improvement from the original design and use will likely increase with time as vegetation is established, as indicated by usage patterns of other wildlife corridors. Two cougars were captured by wildlife cameras utilizing the wildlife corridor underpass on May 29, 2023.

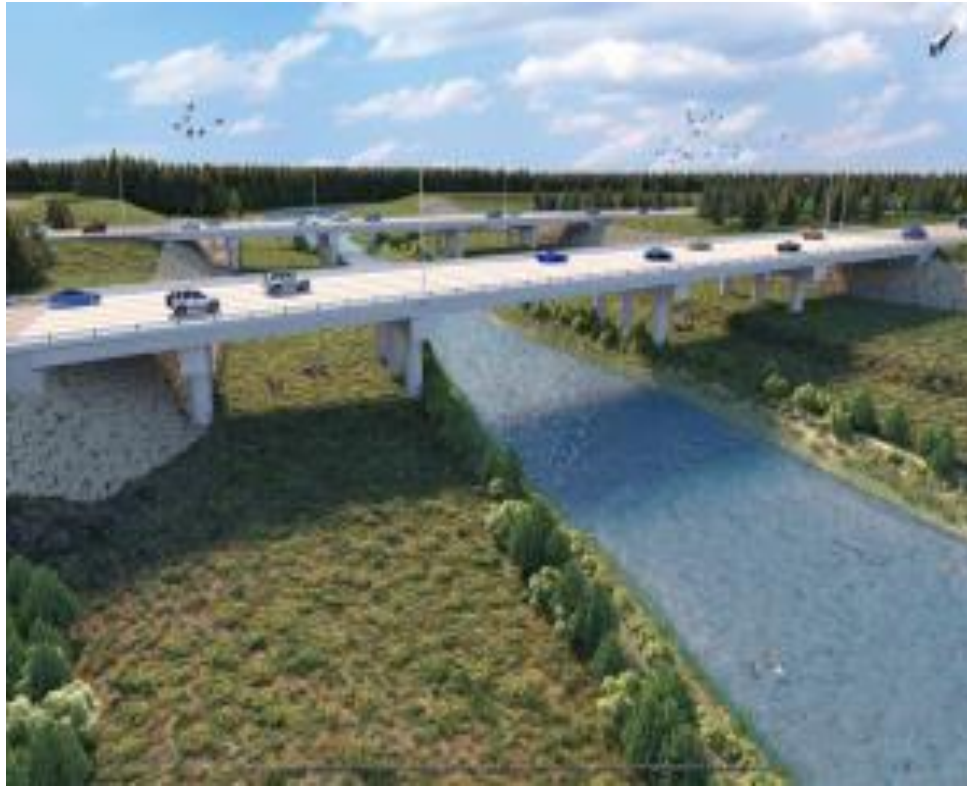
Figure 6. KGL's rendering of the Elbow River Crossing³².

It was acknowledged that revegetation is necessary to provide rest and cover opportunities to facilitate wildlife movement and connectivity¹. The rendering (Figure 6), current state (Figure 7), and revegetation plans (Figure 8) are sparsely vegetated and do not provide suitable rest and cover opportunities. **The Society recommends that the revegetation plans are evaluated to meet these needs.**

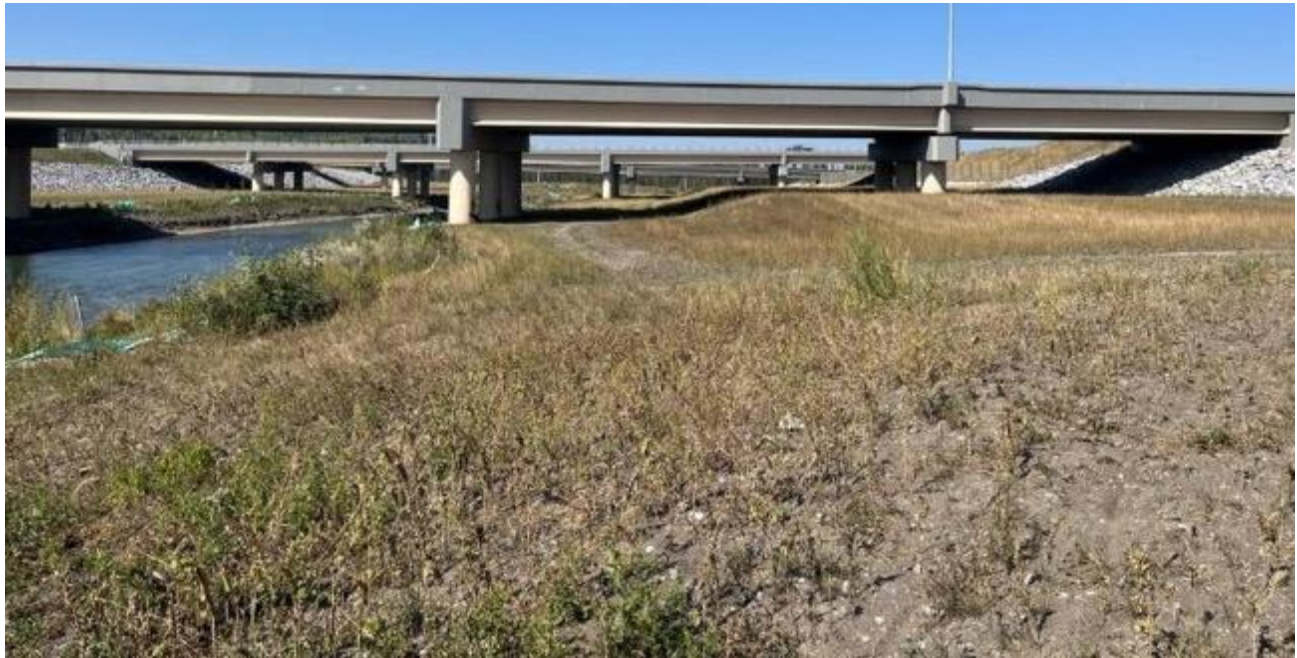
Figure 7. View of the wildlife corridor from the east boundary of the TUC on the north side of the Elbow River. Revegetation along the south side of the Elbow River can be seen along the shore, with limited replanting visible along the north side of the Elbow River wildlife corridor (August 26, 2023).

The January 2020 Monthly Wildlife Monitoring Report noted that *"Mitigations to facilitate wildlife movement during operations (e.g., vegetation plantings and seeding) are installed in accordance with the Technical Requirements?"*, ending the statement with a question mark. Following this, it is also stated that there were deficiencies identified *"to the Technical Requirements as they relate to wildlife considerations and description of corrective actions taken"*, suggesting that the professional biologist preparing the January 2020 report was also concerned that the revegetation efforts do not support wildlife needs (Monthly Wildlife Monitoring Reports, January 2020, p. 7). It appears that there are very few woody plants establishing (Figure 7).

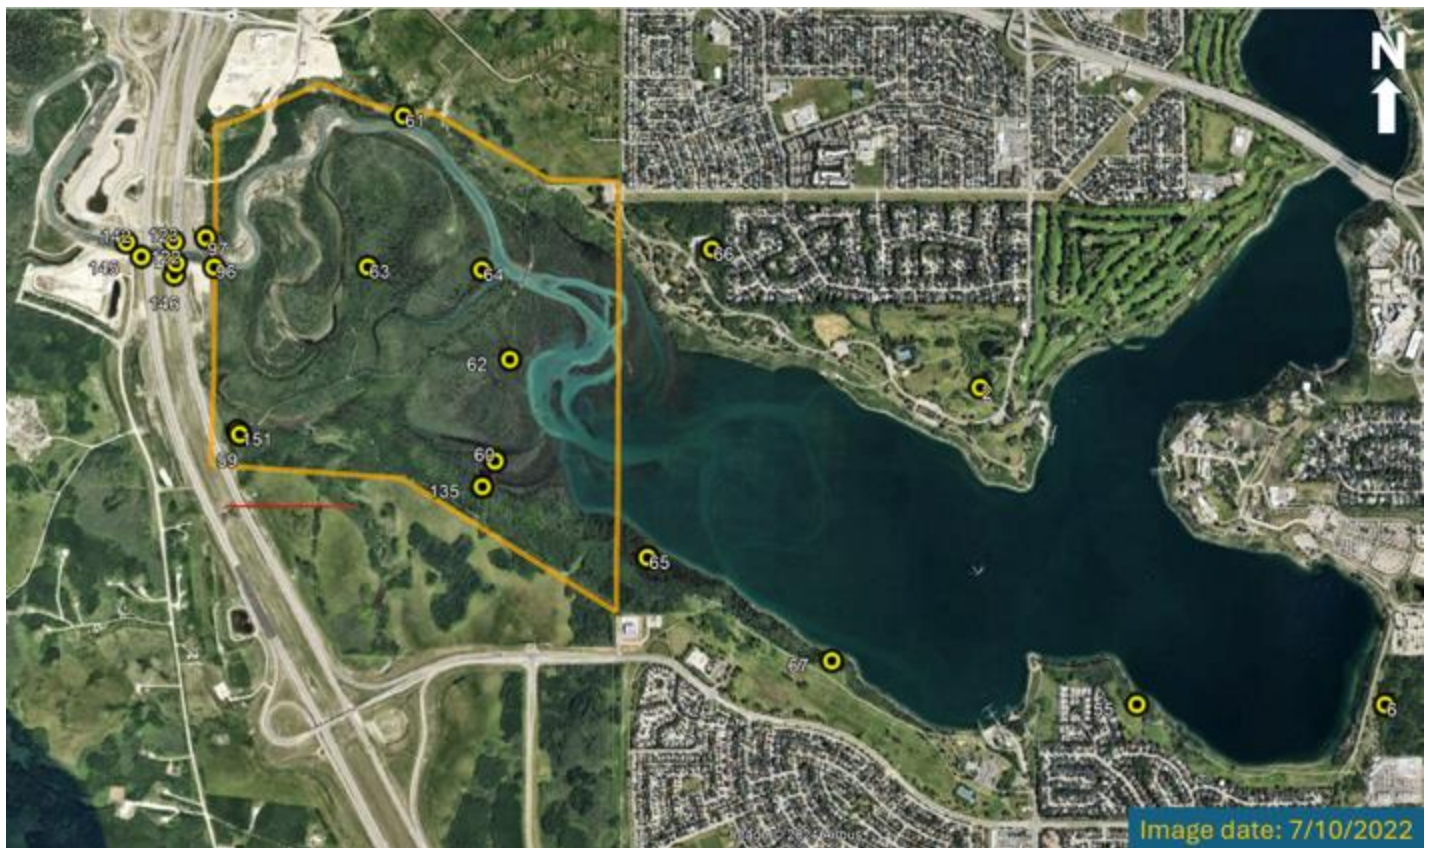
Figure 9. The location of past and current ‘*Calgary Captured*’ cameras (yellow numbered tags) in the Weaselhead area as of 2024 overlaid on aerial imagery from July 10th, 2022 (Google Earth).

In November 2018, the Society partnered with the Miistakis Institute in the project ‘*Calgary Captured*’³³. The goals of this project are to better understand wildlife occurrence in Calgary’s natural areas and to identify key infrastructure associated with roads that wildlife use to move around the urban environment³³. In 2020 and 2021, Miistakis placed cameras at three road mitigation sites, the Weaselhead and Fish Creek Ring Road crossings and Bow River South at Deerfoot Trail (Figure 9)³⁴. They also placed reference cameras within 500 m of these sites and found that not all the species present in the area were using the wildlife corridors³⁴. The locations of *Calgary Captured* cameras at the time of writing are shown in Figure 9.

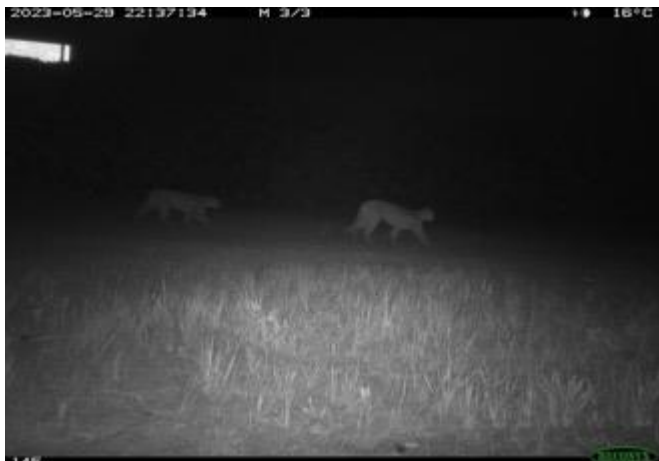
Figure 10. 'Calgary Captured' photo of cougars moving under the bridge in the wildlife corridor. May 29, 2023, 10:37pm, camera #145, see Figure 9 for location.

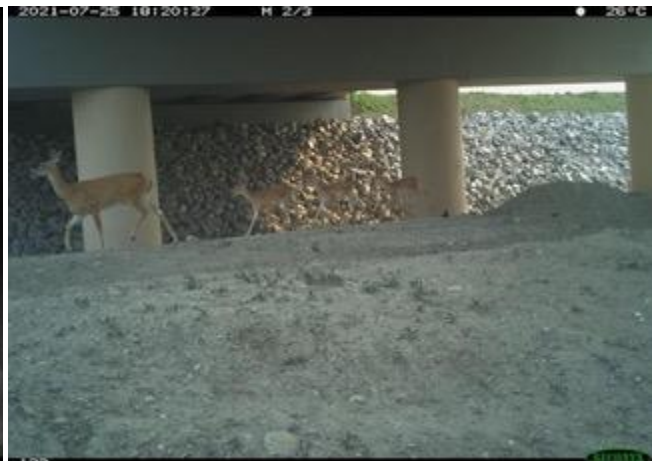
Figure 11. 'Calgary Captured' photo of deer under the SWCRR Elbow River bridge in the wildlife corridor. July 25, 2021, 6:20pm, camera #123, see Figure 9 for location.

The Monthly Wildlife Monitoring Reports indicated observations of large mammal presence in the buffer regions but limited evidence of the corridor itself, however 'Calgary Captured' cameras have been able to confirm wildlife use under the bridges, including deer and cougar use (Figures 10 and 11)^{6, 34, 35}. Clevenger et al. found in Banff that cougars easily travelled the various wildlife crossing structures and used open-span bridge underpasses more than expected³⁶. Other wildlife crossing structures in Banff were used less than expected by cougars, suggesting that the existing wildlife corridor in the Elbow River valley may be the best option for cougars³⁶.

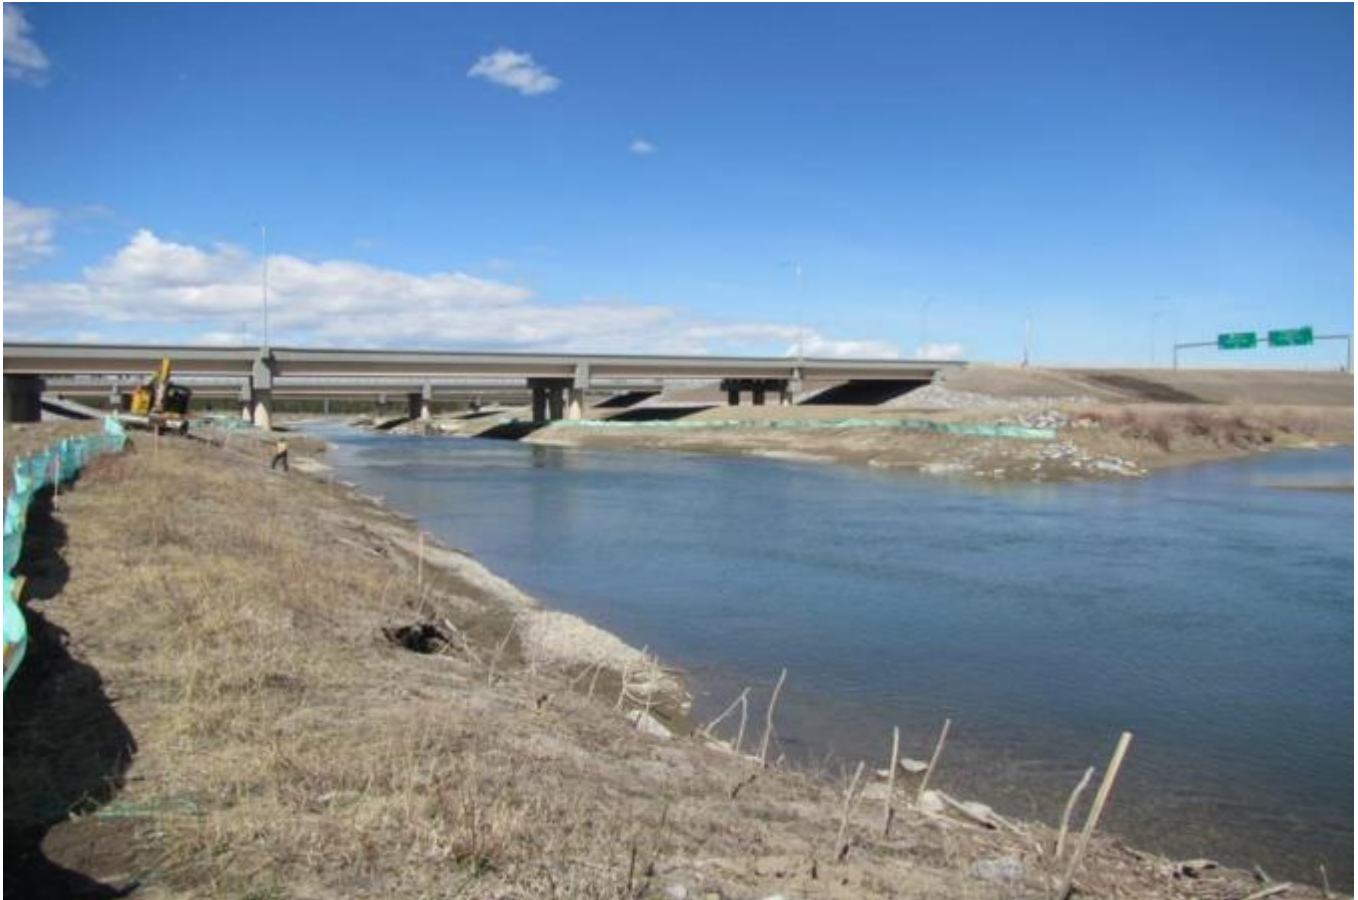
Figure 14. View looking Northwest, from the south bank of the Elbow River over the SWCRR showing the wildlife corridors in May 2021. Workers can be seen on the south bank using heavy equipment along the realignment corridor for willow staking. (Photo taken by Golder during the May 2021 Monthly Wildlife Monitoring Report⁶). Green fencing visible on both sides of the river is erosion control fencing and is not a part of temporary or permanent wildlife fencing.

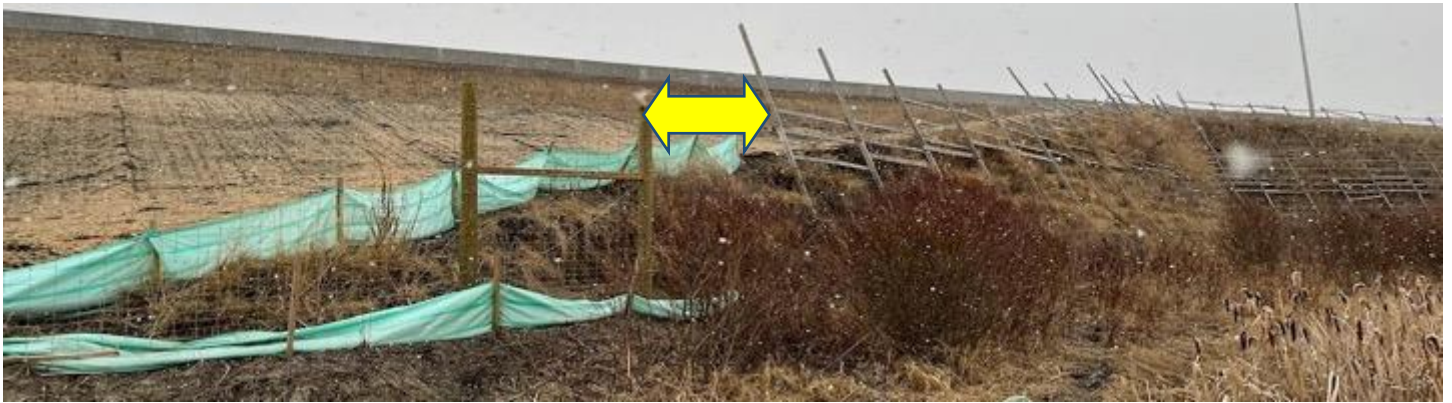
Figure 17. A visible gap at the fencing end exits at the start of the retaining wall, highlighted by the yellow arrow, was first observed in early 2022 west of the Beaver Pond and south of the retaining wall. Green fencing in the photo is erosion control fencing.

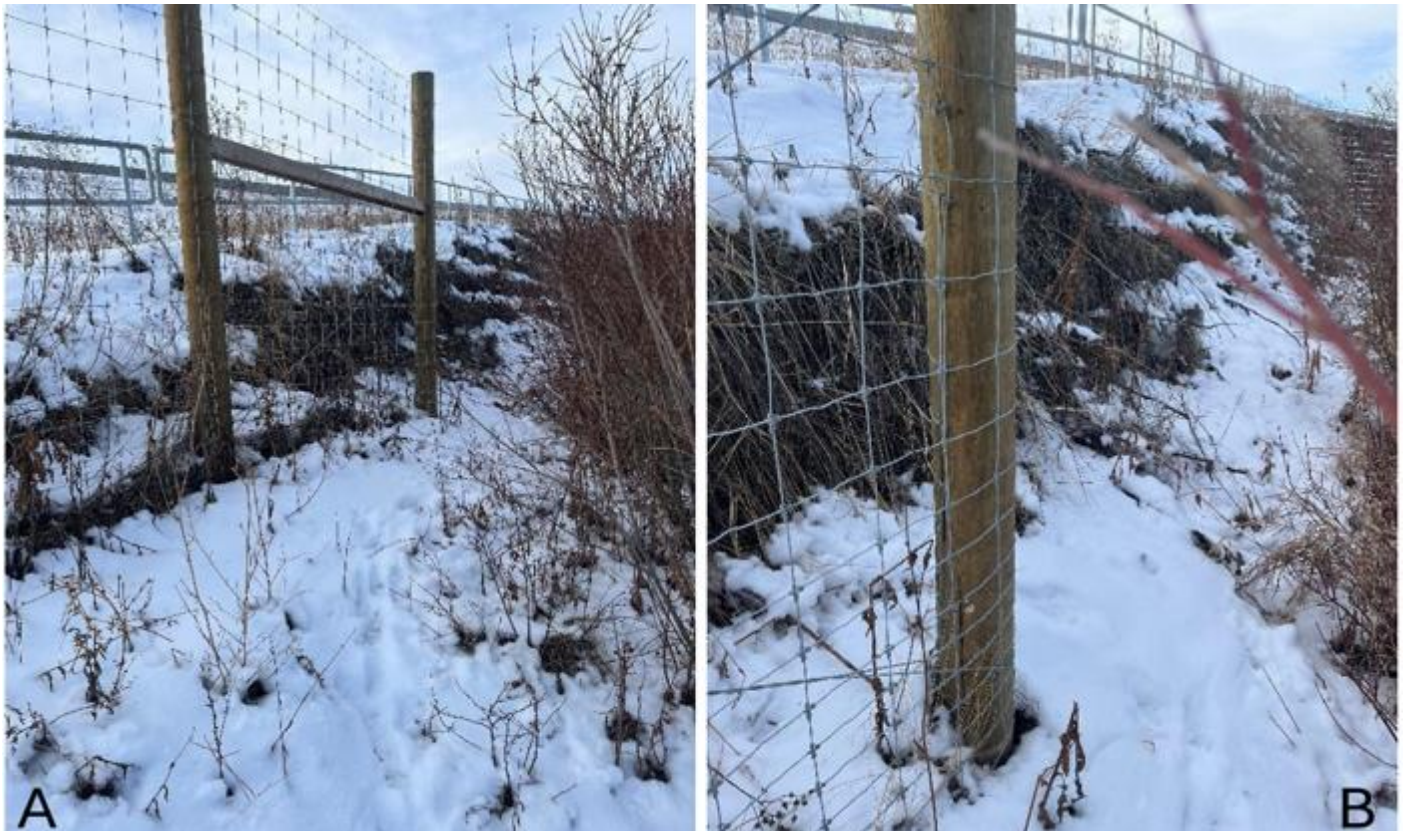
Figures 18A and B. Photographs showing wildlife tracks mainly of ungulate and canine species leading up to and around the fence gap at the west end of the Beaver Pond where fence ending meets the retaining wall. (Photos taken December 15, 2023. Same location as seen in Figure 20).

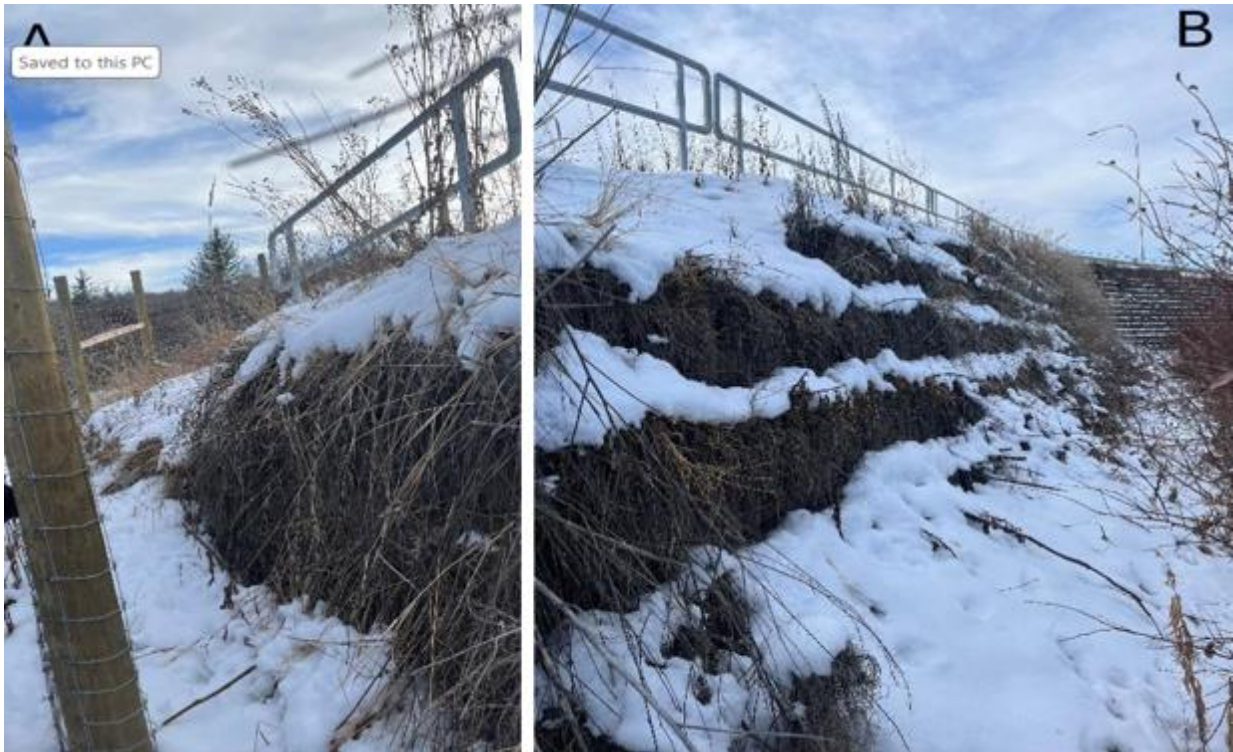
Figures 19A and B. Photographs taken at the 3-foot gap show the gap is utilized by wildlife, with both ungulate and canine tracks heavily overlapping in the snow reflecting common use patterns. Figure 20A shows the gap facing south and 20B shows the view through the gap north, towards the retaining wall. (Photos taken December 15, 2023).

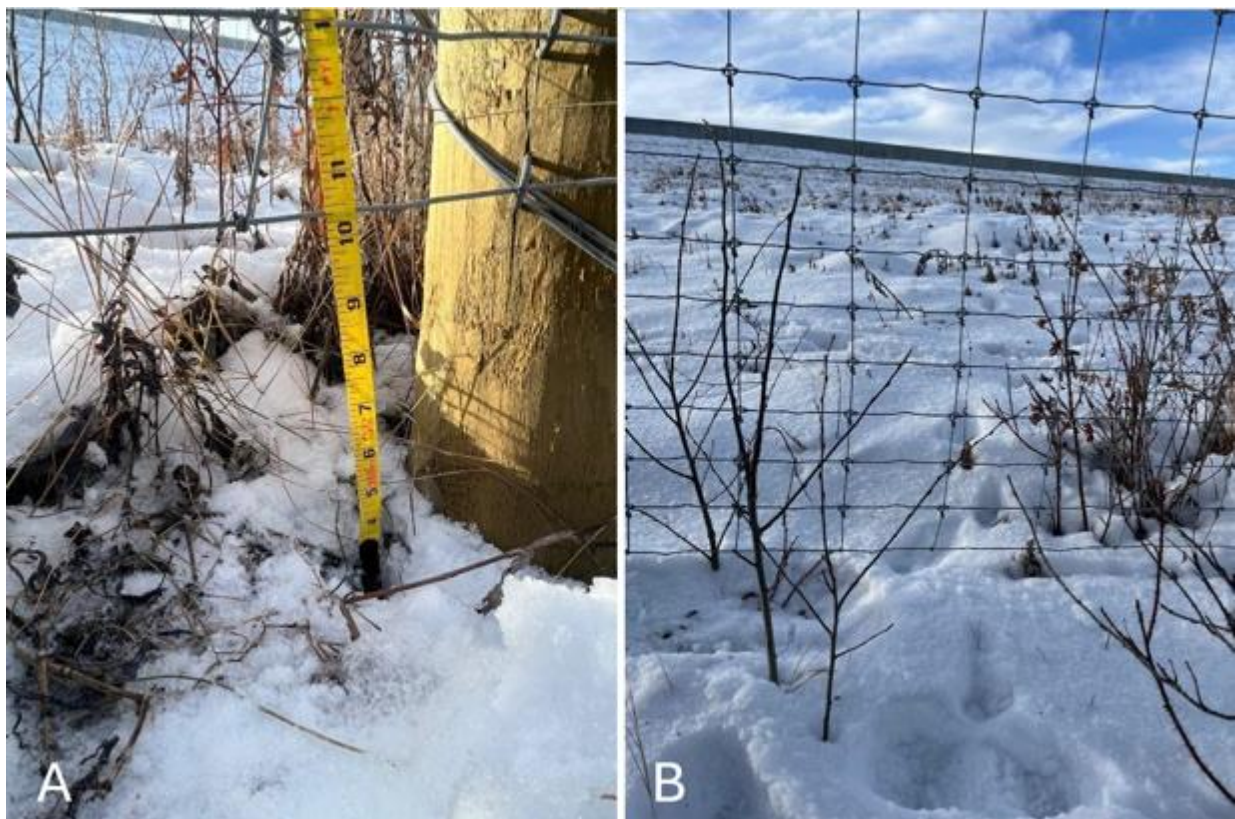
ground to fence gap of 75 mm (Figure 15)¹². Coyote fur was discovered caught under one of these gaps and tracks were observed going under the fence in several spots (Figure 20B). Similarly, specifications for a gate installed in wildlife fencing indicates a maximum clearance from the bottom of the fence to the ground of 75 mm, a maximum spacing of 50 mm between both sides of the gate and a maximum spacing of 75 mm between the gate and the gatepost (Figure 15)¹². The access gate located at the west end of the Beaver Pond also does not meet the standards set in the requirements. **The Society recommends that further investigations to determine the shortcomings in the wildlife fencing installed take place and improvements are made to meet the Technical Requirements to ensure both the safety of drivers using the SWCRR as well as that of animals that cross into and out of the park¹².**

Figures 20A and B. Photograph of the fencing along the west end of the Beaver Pond on the eastern edge of the SWCRR, which displays a large 10.5" gap between the bottom edge of the fencing and the ground surface. Animal tracks are visible passing under fencing suggesting that this area is utilized for animal movement. (Photos taken December 15, 2023).

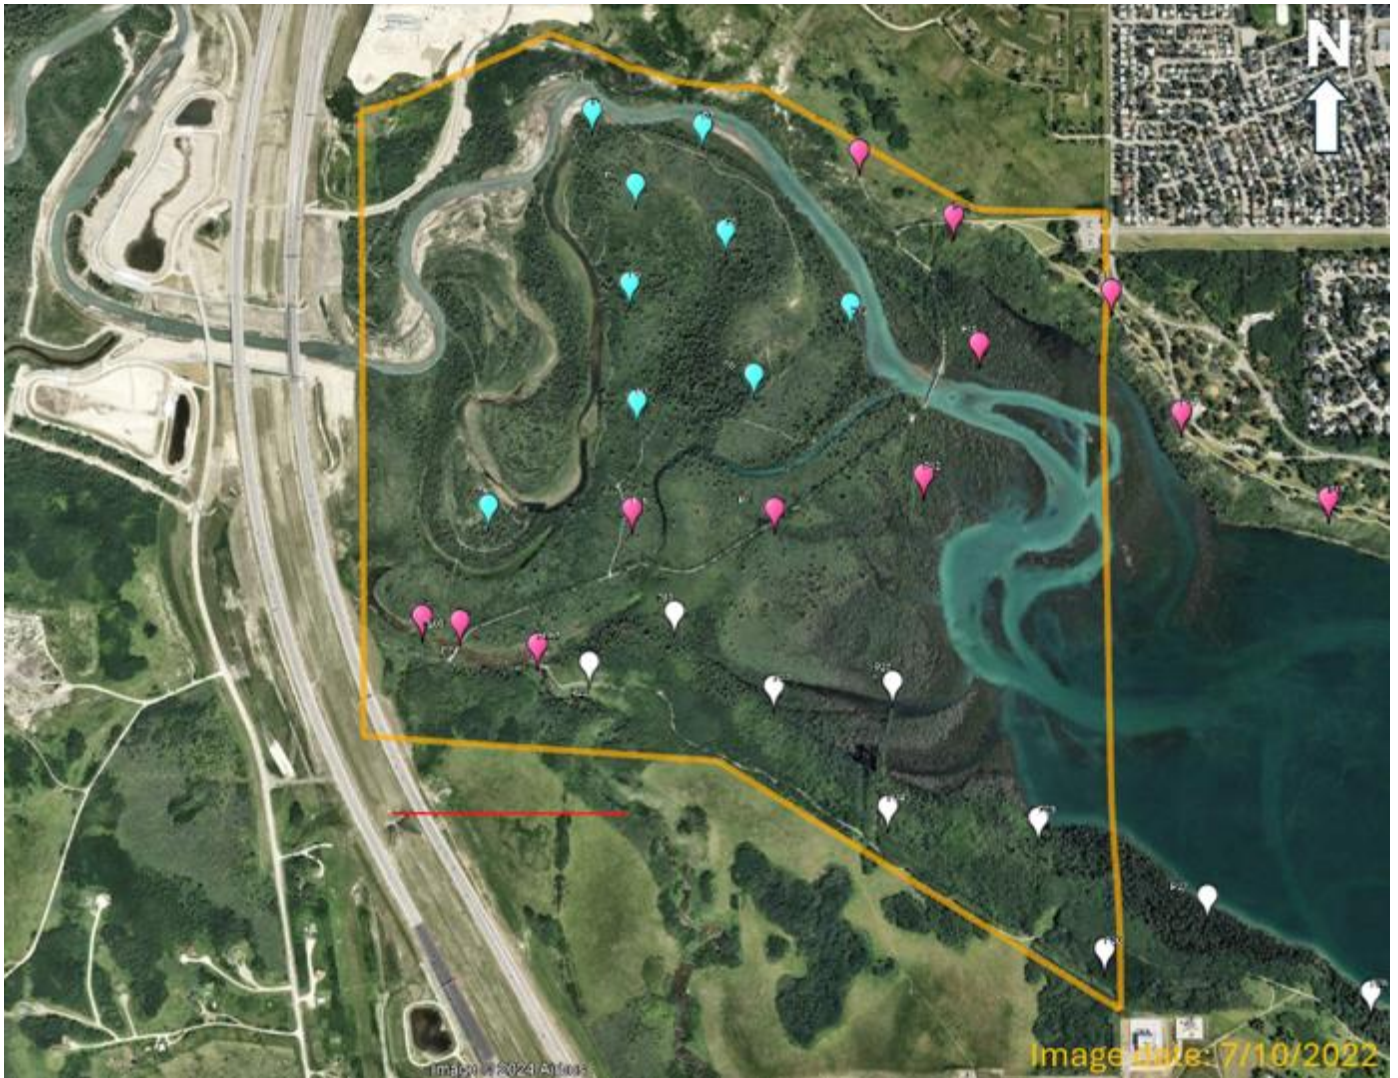
Figure 21. Location of breeding bird survey points in the Weaselhead. The survey points are colour coded to the bird survey teams. (Weaselhead boundary: orange line; red line = 500 m scale; Google Earth; July 10, 2022)

Our research followed the methodology of the fixed-radius point count survey conducted in 2011 for the 2014 EIA, which was then repeated each year over the Study period, with additional observations collected from eBird for the Weaselhead Study Area each year^{1, 3, 50}. These annual surveys were conducted at the same survey points as identified in the EIA (Figure 21)^{1,3}. These points were used as the noise survey sampling locations (Figure 21)³. The protocol was repeated annually, and methodology and results are detailed in the annual Environmental Monitoring Reports from 2016 – 2022³.

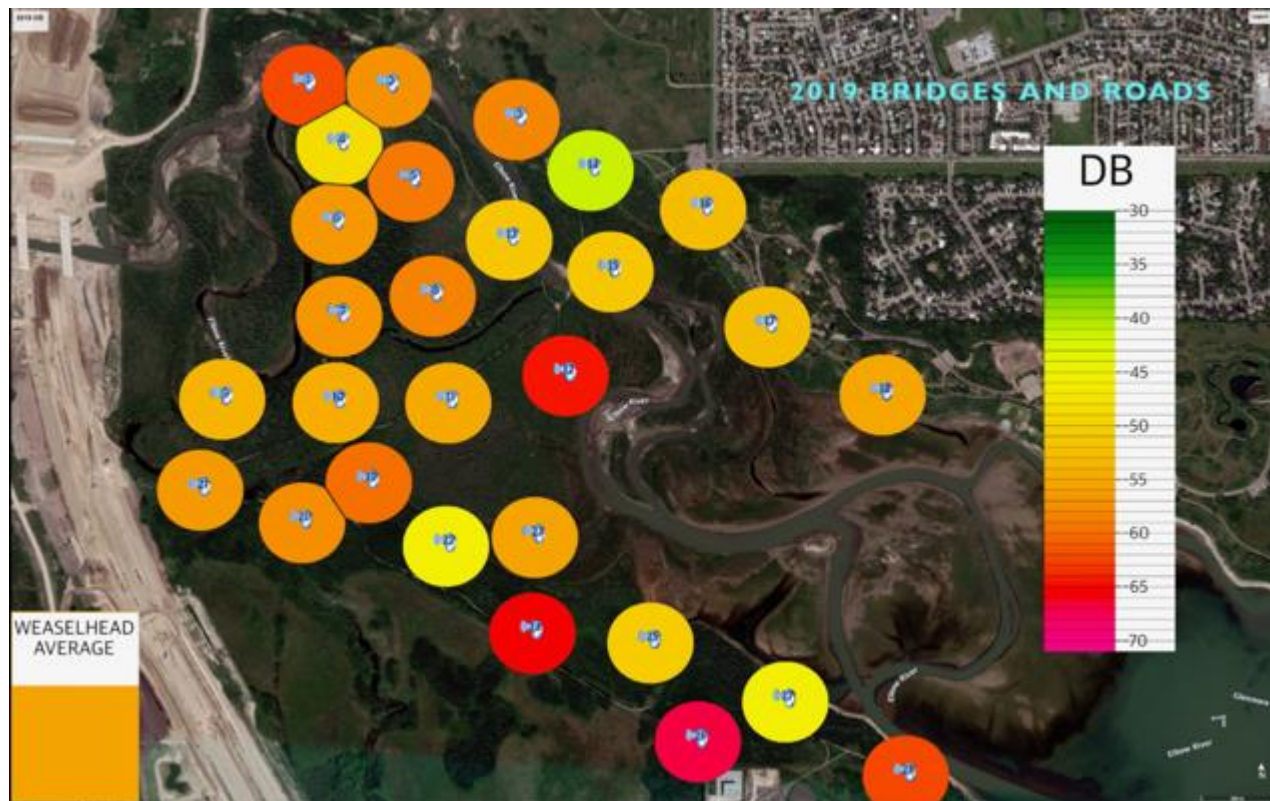
Figure 23. Average noise reading at each noise sampling station in 2019 overlaid on Google Earth Imagery. Still taken from WGPPS Noise Measurement 2016 - 2022 video which shows changing noise averages at each station over time from 2016 to 2022⁶⁴.

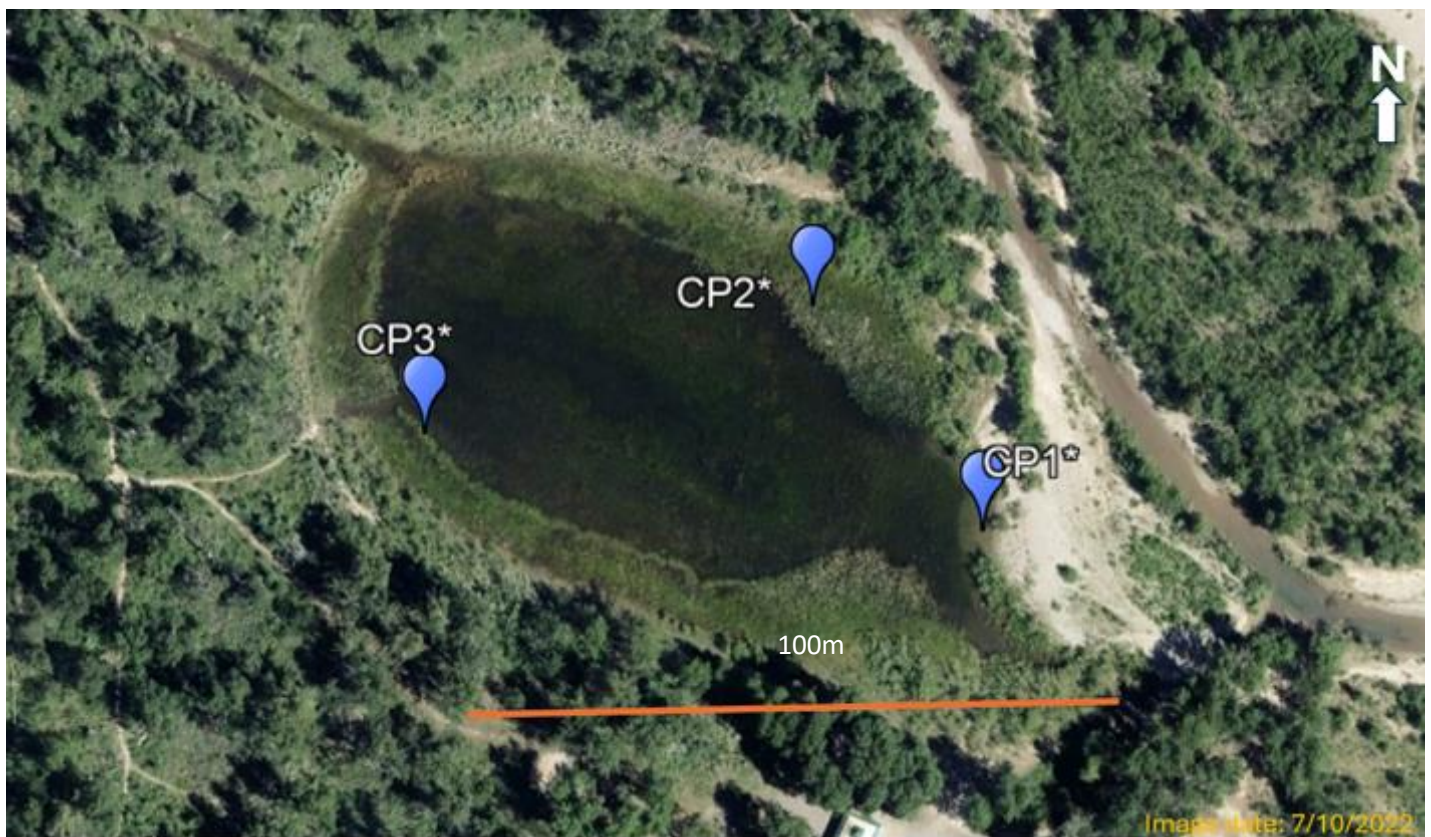
Figure 29. Location of 3 sampling sites at Clearwater Pond; (blue symbols: site locations; red line: 100 m scale bar; *Google Earth*)

Water quality in an additional wetland, Clearwater Pond, was also assessed in the Elbow Valley, upstream of the SWCRR construction zone and not located in the Weaselhead (Figures 27 and 29). It is intended to represent a reference site against which to compare changes observed in the Weaselhead wetlands. The Beaver Pond is in immediate proximity to the SWCRR (Figure 28). The Beaver Lagoon with which it is hydrologically connected, is further downstream (Figure 28).

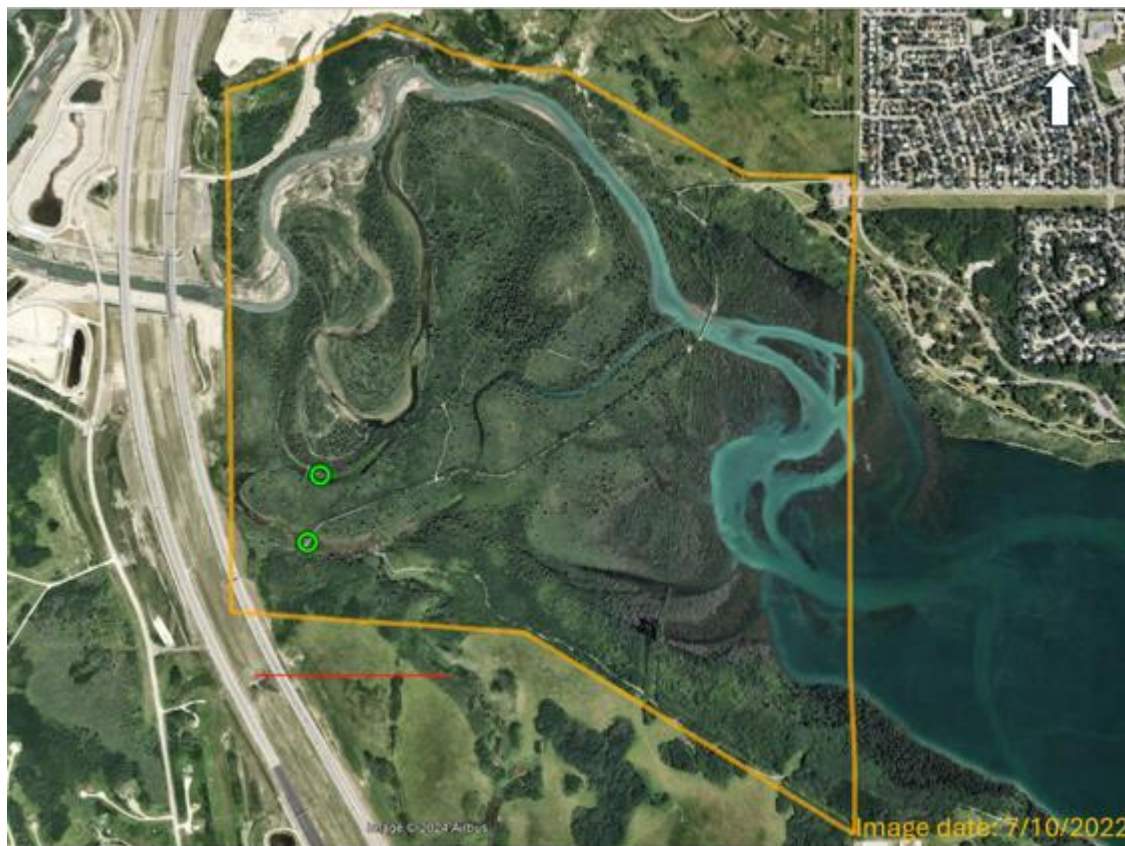
Figure 33. Locations of amphibian call survey monitoring sites from 2017 to 2022 indicated by green circles. (Weaselhead boundary: orange line; Red line = 500 m scale, Google Earth)

Nocturnal amphibian call surveys were done at two locations in the Weaselhead from 2017 to 2022 (Figure 33). Only boreal chorus frogs, *Pseudacris maculata* and wood frogs, *Lithobates sylvaticus* were detected. The locations match two used in 2012 and are close to one used in 2014 for the EIA. Surveys were carried out between 9pm and 11pm for 20 minutes, following a protocol developed by the Miistakis Institute for 'Call of the Wetland', a three-year study (2017 to 2019) into amphibians in the Calgary area⁷⁸.

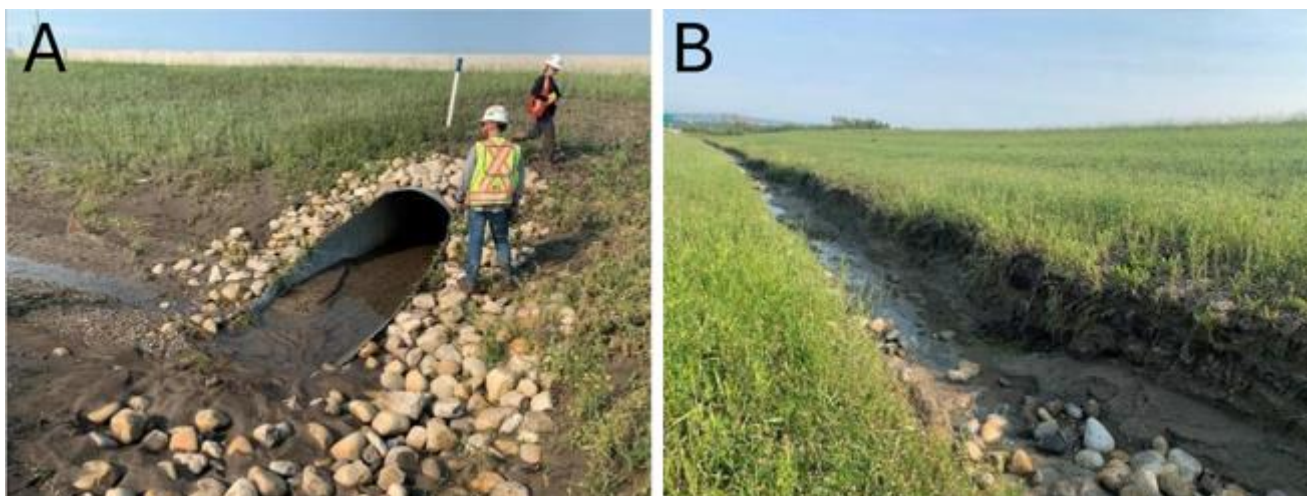
Figure 34A and B Silt inundation of western culvert berm (A) and channel erosion within ditch alignment (B) after rain event. (Taken From Hemmera WAIR⁶⁵)
