Weaselhead/Glenmore Park
Southwest Calgary Ring Road Environmental Impact Study 2016-2022

Final Report

Environmental Impacts from the Southwest Calgary Ring Road Project
on the Weaselhead Special Protection Natural Area:
Field Studies from 2016 through 2022 with Interpretations and
Recommendations

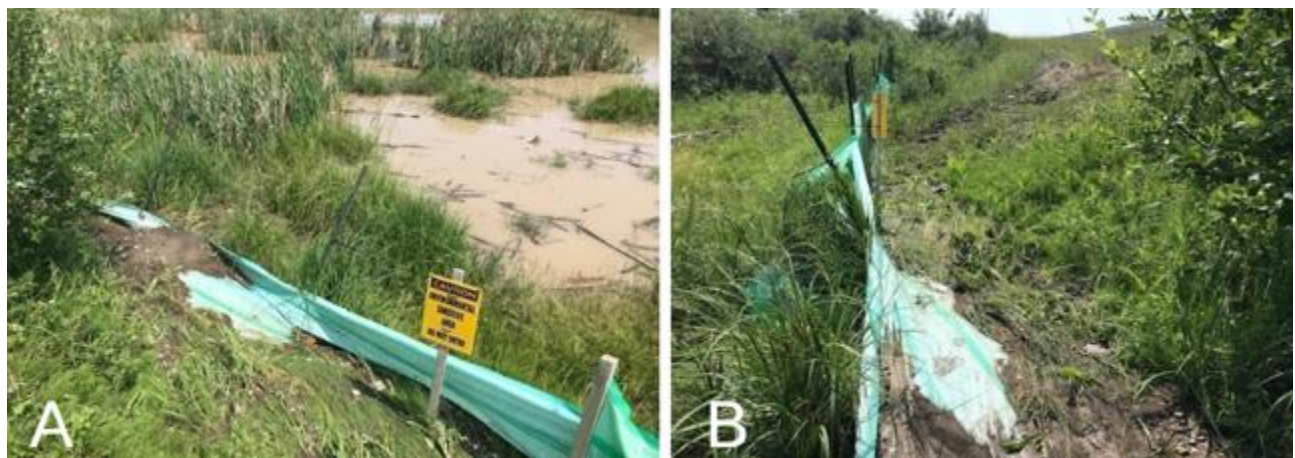
Figures 36A and B. Photographs of the Beaver Pond in the Weaselhead, identified as ‘Environmental Sensitive Area’, following sediment and course infill mitigation failure resulting in contamination of the wetland. Note the same failed mitigation measure used on top of the buried sediment fencing. (Taken July 3, 2021)

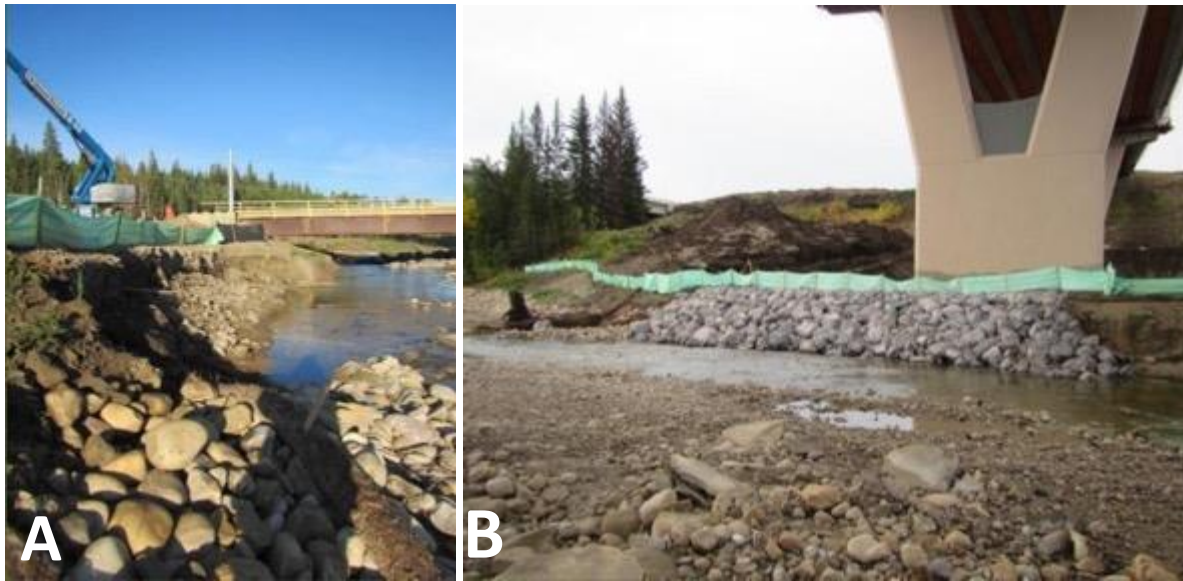
Figure 39A and B. Photo A is taken facing westward showing the erosion on the southern back of Fish Creek, under and east of the local bridge. (Photo from KGL August 2019 Monthly Wildlife Monitoring Report⁶). Photo B is taken facing southeast under the bridge showing repaired erosion south of Fish Creek diversion. (Photo from KGL September 2019 Monthly Wildlife Monitoring Report⁶).

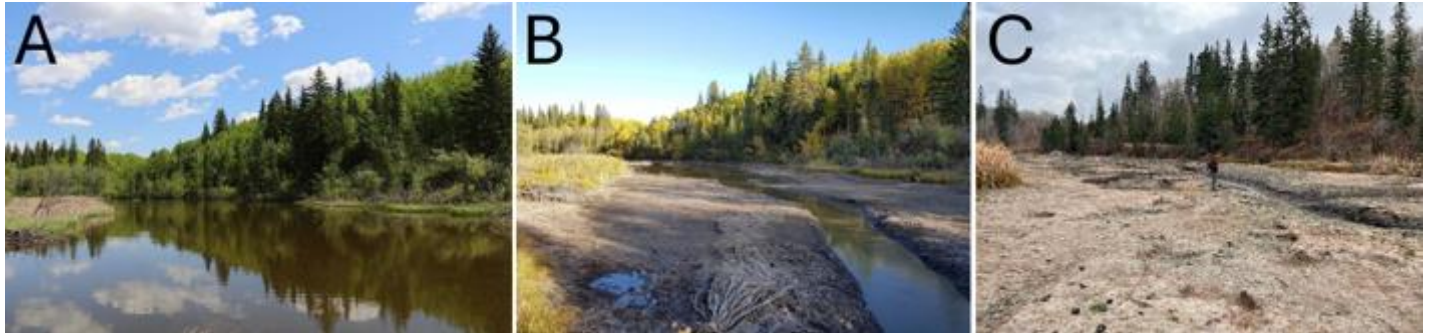
Figures 40A, B, and C. Photographs of the Beaver Pond in the Weaselhead, showing progressive water loss from 2017-2022. (A) is taken by Yves Dansereau on May 27, 2017 (B) is taken on Sept 23, 2017, and (C) is taken on Oct. 21, 2022 all taken from survey point 21, facing east.

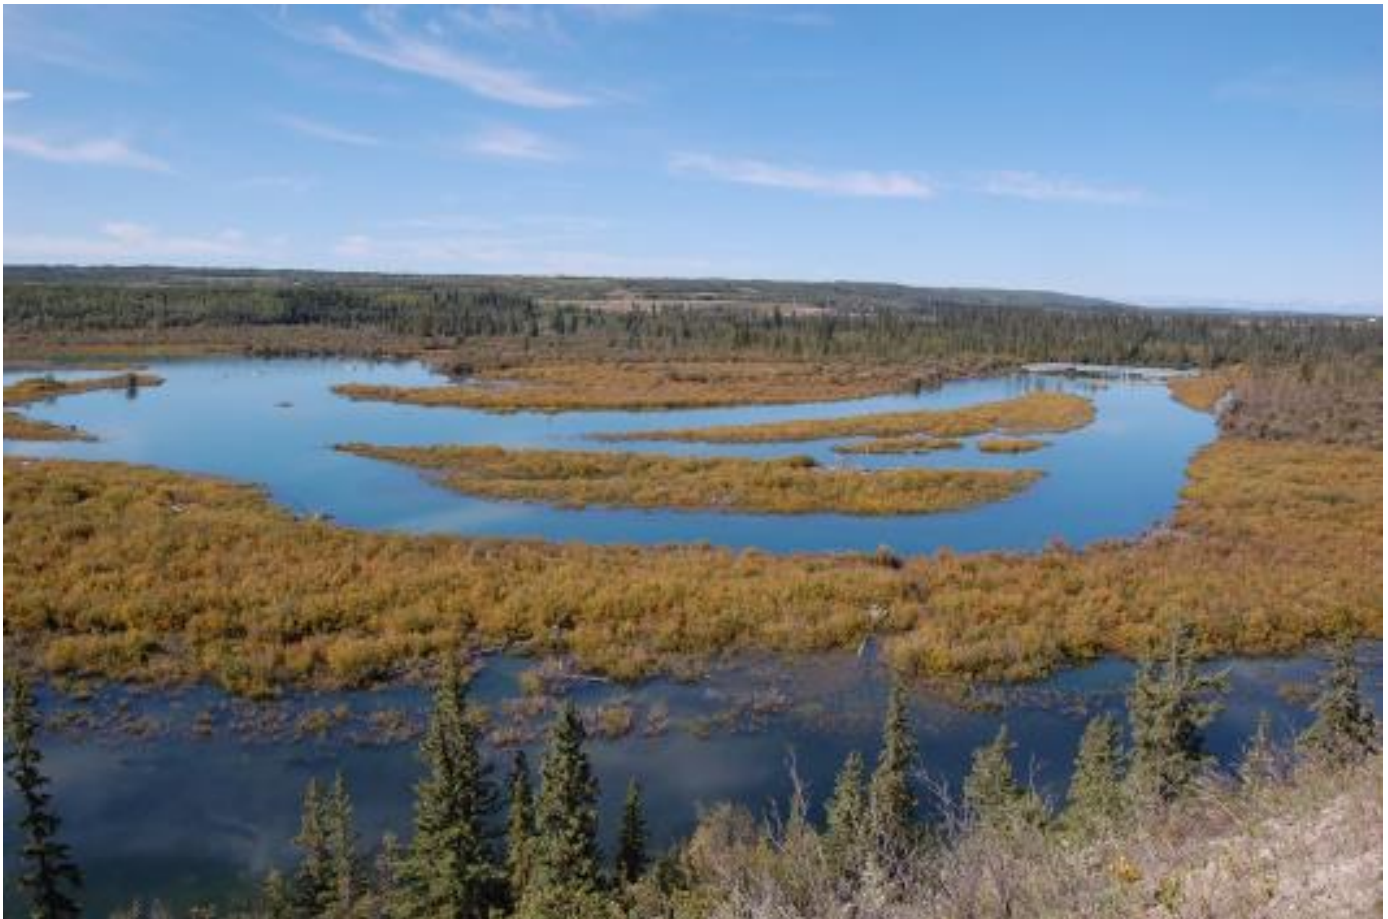
Figure 42. A southwest-facing overlook of the Elbow River Delta in Weaselhead Flats, with the pathway bridge on the right. The tall shrubs displayed in the photo extending up to the regional pathway are expected to have major die off and habitat changes. Die off has been more noticeable in spring 2024 (Photo by Stewart Rood, September 3, 2021).

The City of Calgary improved the Glenmore Dam with restoration efforts completed by September 2020. Water levels were raised by approximately 1.5 m resulting in significant changes to the riparian vegetation and banks along the reservoir and Weaselhead Flats. This is an additional factor that influences our aquatic invertebrate data due to terrestrial plants submerged at sample sites. The raised reservoir results in substantial flooding of the willows on the Elbow River Delta. The inundation and especially submergence will result in mortality of the willows, dogwood, and other riparian shrubs (Figure 42). Dr. Stewart Rood of the University of Lethbridge hypothesizes that: *“The repetitive and prolonged flooding will lead to progressive mortality of the extensive riparian willows (Salix spp.) in the delta zone where the Elbow River flows into Glenmore Reservoir. This might be followed by some upward transitions of willows and alders (Alnus spp.) and some localized die-back of spruce (Picea glauca). Unlike the Bow River through Calgary, the Elbow River valley has more limited balsam poplars (Populus balsamifera).”* (S. Rood, personal communication, September 6, 2021). Willow and spruce mortality are visible near the reservoir and the dieback is expected to be extensive. These alterations are independent from the SWCRR Project, the timing is coincidental though there may be cumulative impacts from the roadway and reservoir projects. This development raises several questions regarding the engineering of the SWCRR Elbow River valley crossing. Is the SWCRR Project engineered to accommodate this change in the reservoir level? Are there any engineering concerns with the change in groundwater levels and the stability of the structure foundations during a flood event?

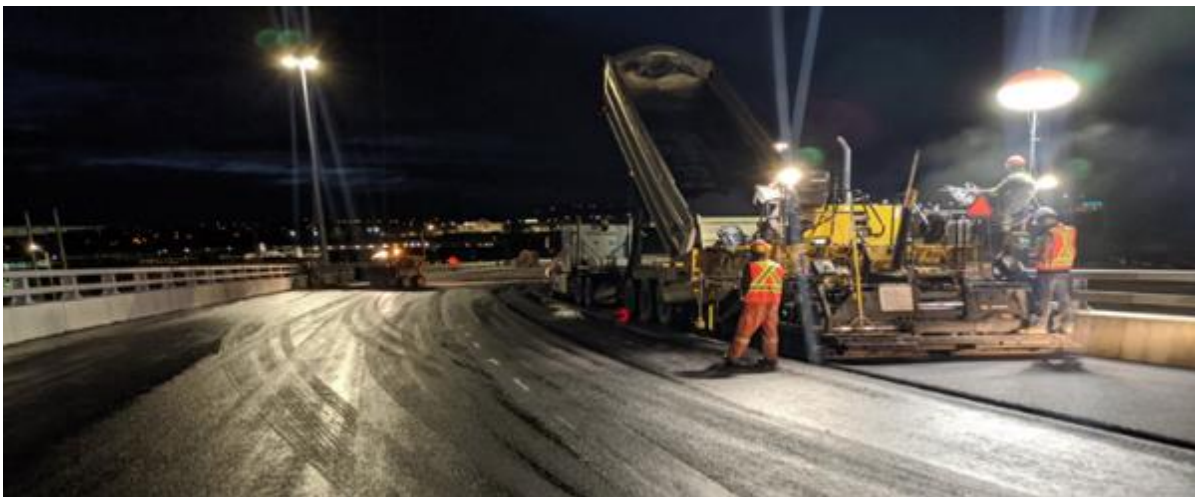
Figure 43. Nighttime working Sept 2020, showing construction lighting similar to those observed in Aug 2020. (Image provided by KGL⁸⁹)
