Weaselhead/Glenmore Park  
SWCRR Impact Study 2016-2022

**Environmental Monitoring Report 2021**  
birds, noise, vegetation, wildlife movement, water quality, aquatic invertebrates,  
amphibians, fish.

Author: Cassiano Porto, Lisa Dahlseide & Dylann Golbeck  
Calgary, May 2022

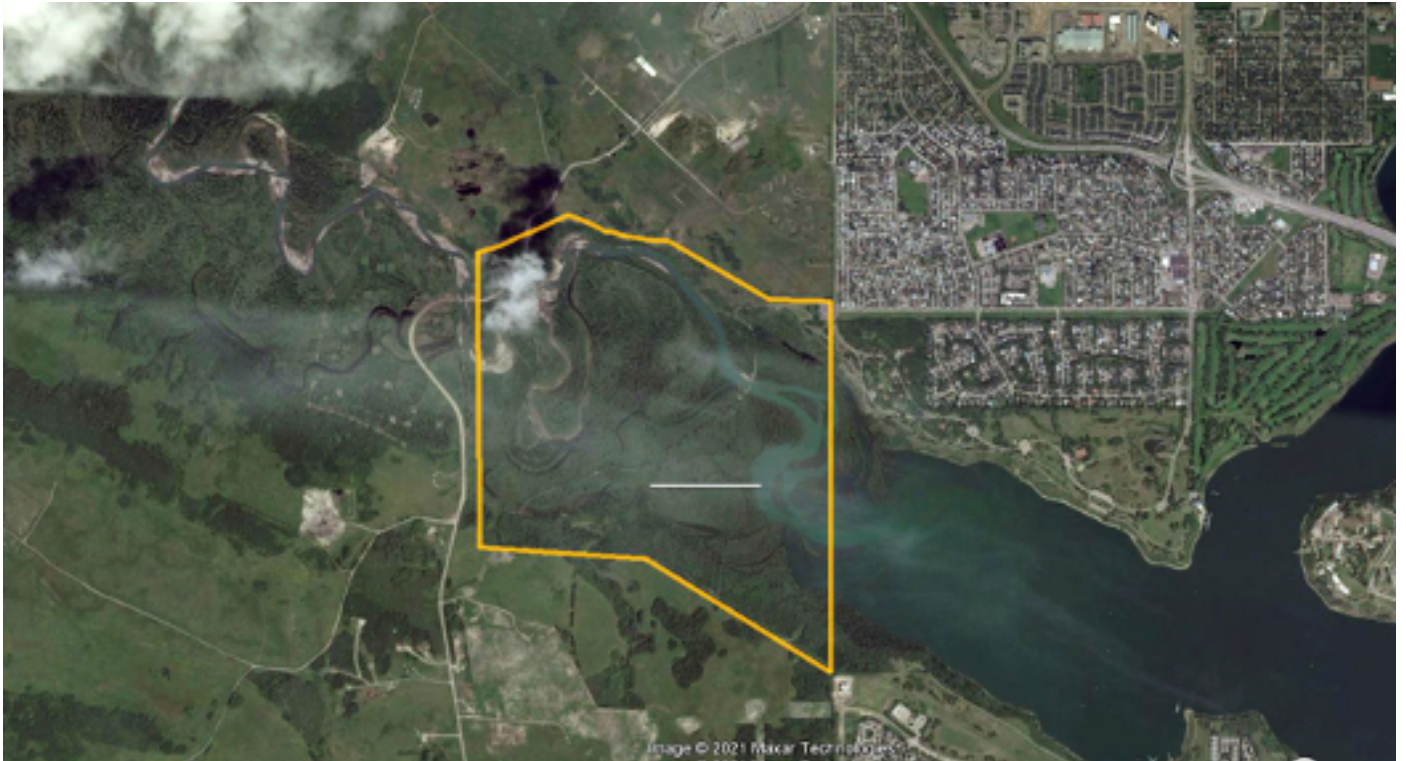
Figure 2A. An aerial image Sept. 8, 2016 before major construction began (downloaded from Google Earth); orange line shows Weaselhead boundary; scale: white line = 500 m.

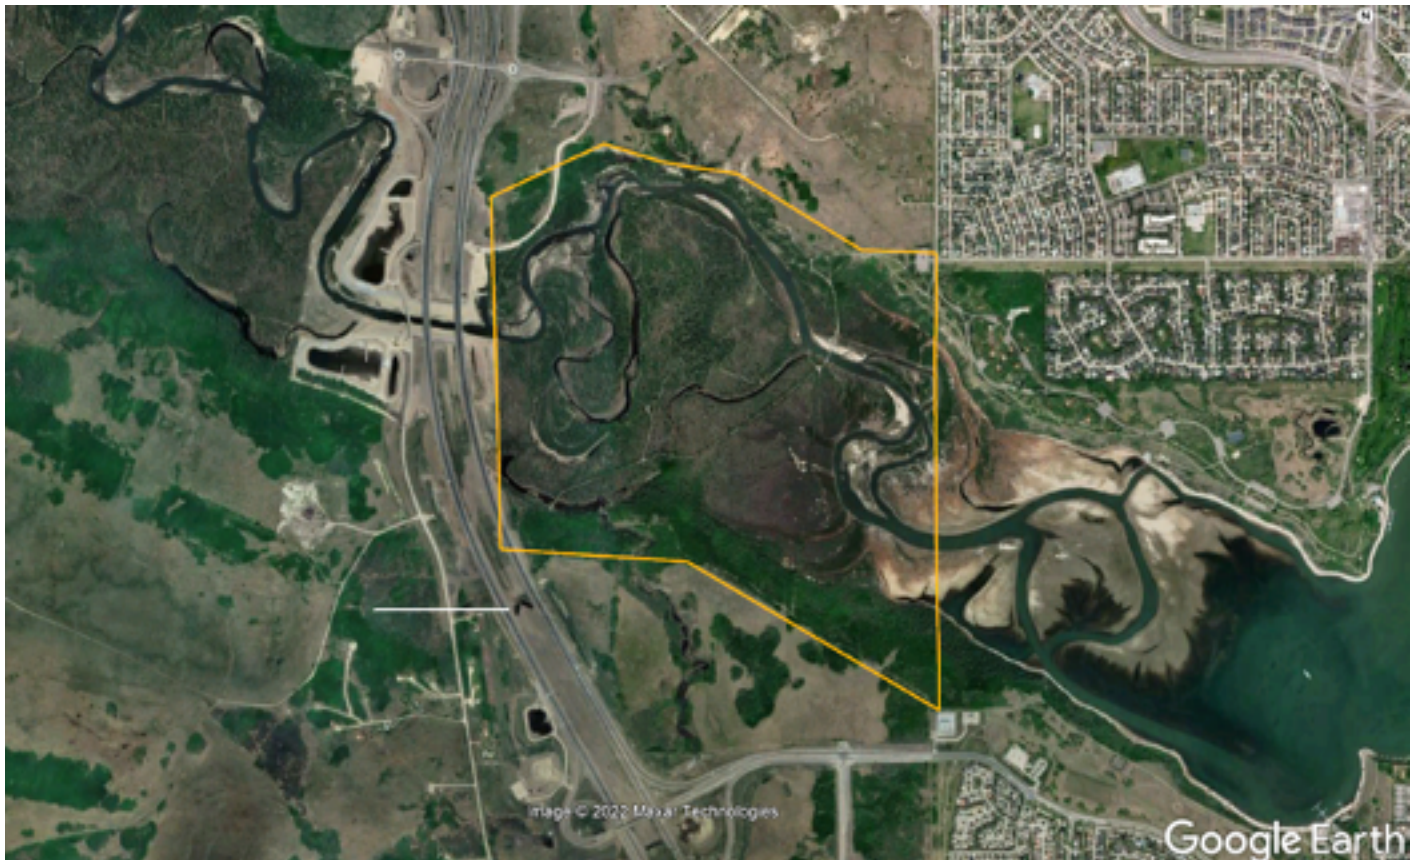
Figure 2B. The same area in May 30, 2021, with the SWCRR nearly complete; of the Weaselhead and its boundary shown by orange line; scale: white line = 500m.

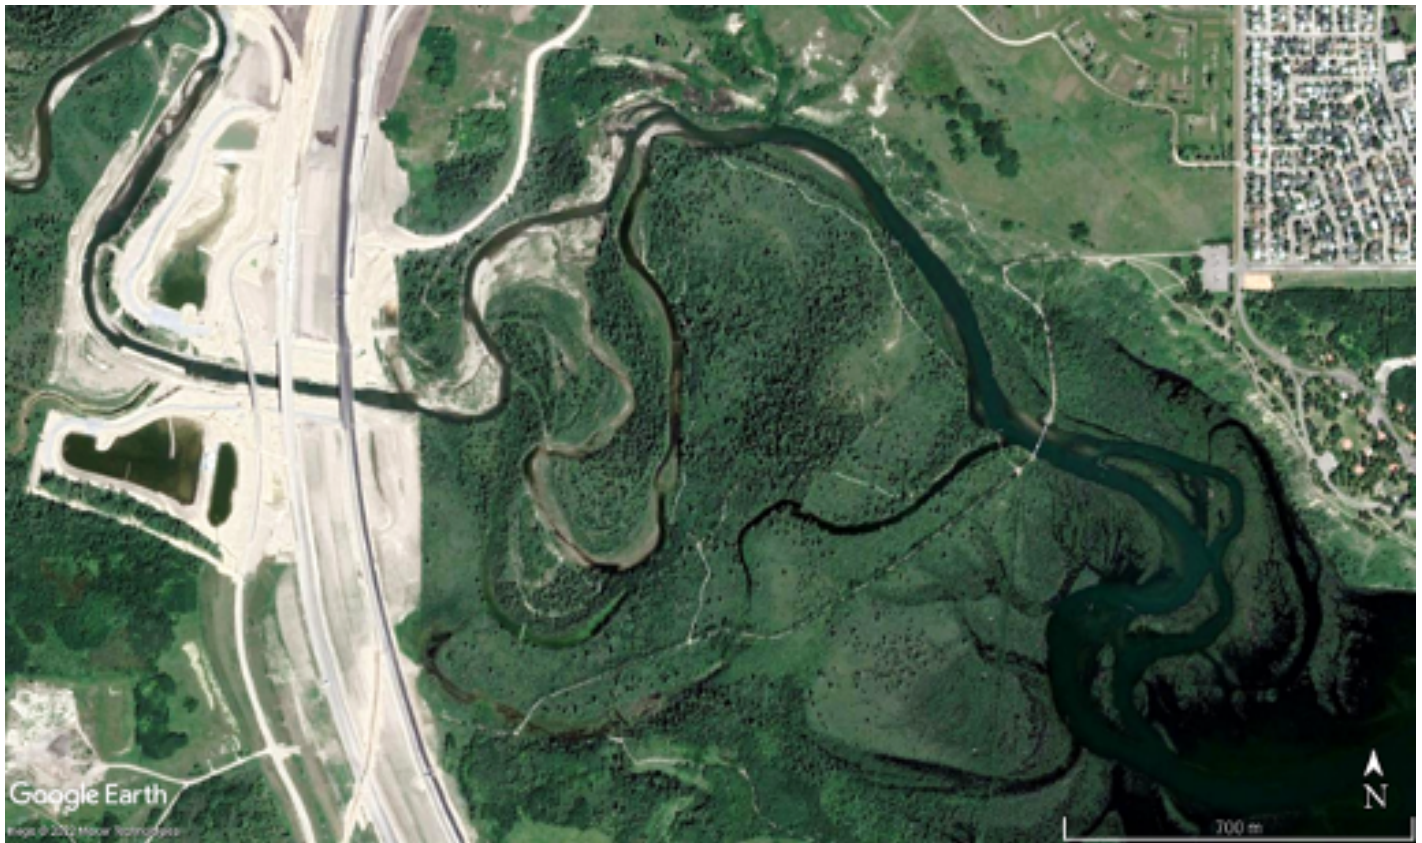
Figure 3. An aerial view of the Weaselhead with the SWCRR under construction and the different hydrological features indicated (Aug. 4, 2020).

When contrasted with the baseline conditions of 2016, later conditions offer insights into the long-term effects of the SWCRR on the adjacent ecosystems. These ecosystems included different features within the Weaselhead, with mapping and designations provided in Figure 3.

The realignment and straightening of the Elbow River channel (Figure 3) will also substantially alter the hydrology through the floodplain system at Weaselhead. The unnatural channel position is fixed with the bridge pillars and bank armoring, which may be increased as the river works to re-establish some sinuosity. The alignment somewhat provides a flume that is likely to extend the meander lobe immediately downstream. Over time the channel may further extend eastward and there could be some reconnection of the abandoned channel to the New Oxbow (Figure 3). This could increase the surface and groundwater flow to the southern zone, where the Horsetail Marsh/Old Oxbow and Beaver Pond occur.

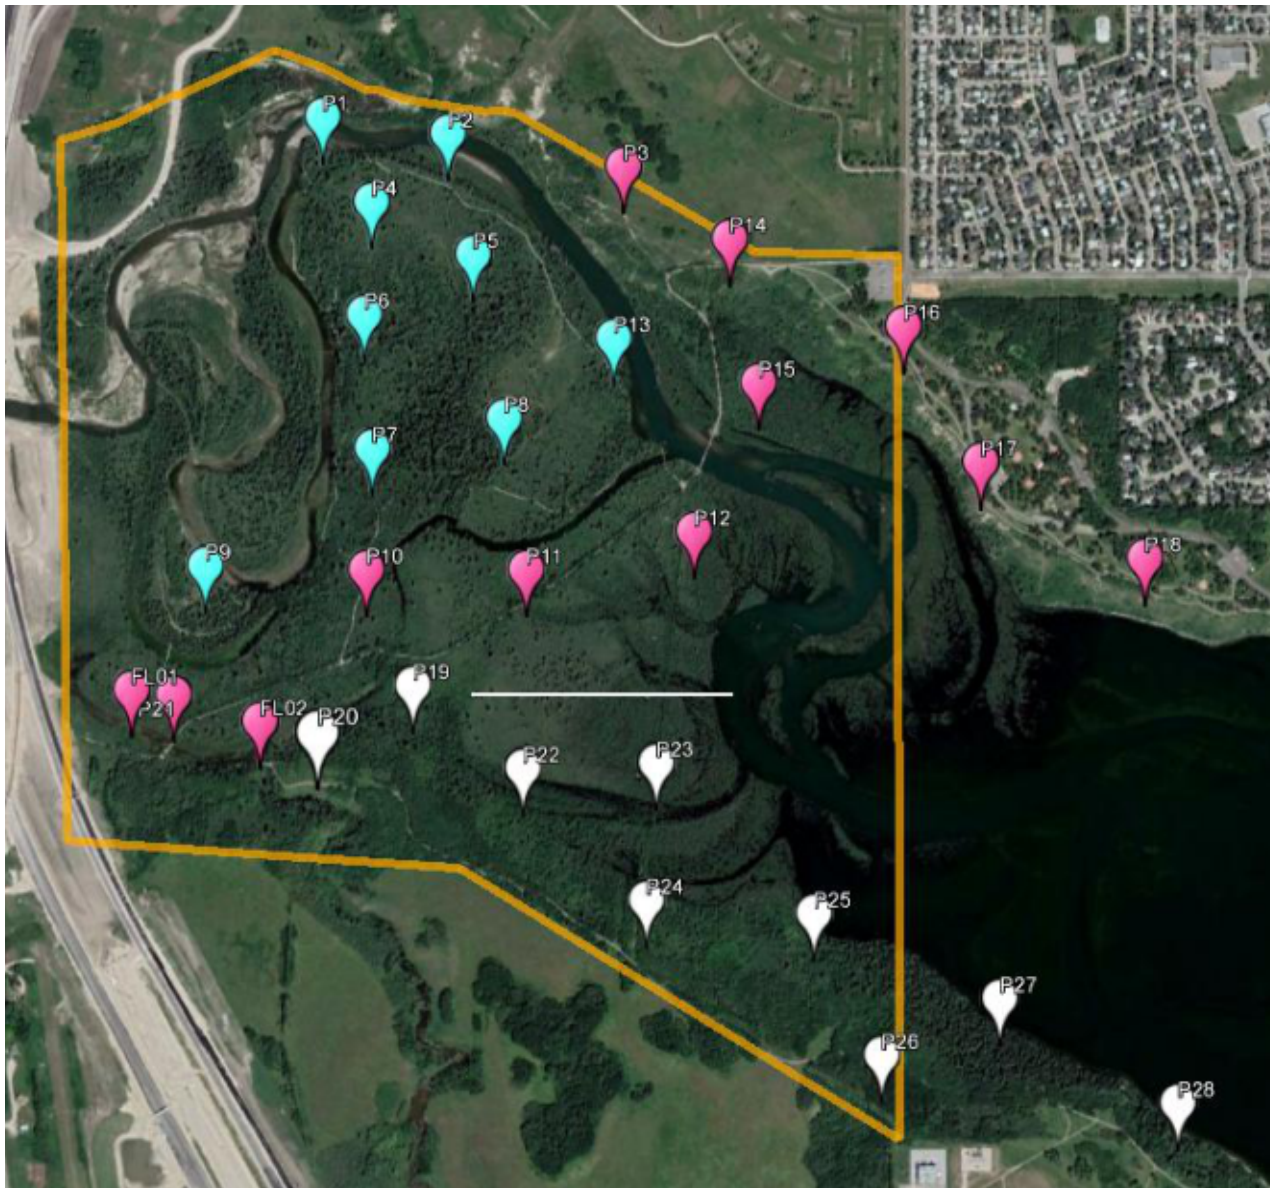
**Figure 4. Location of breeding bird survey points (scale: white line = 500m)**

Volunteer groups were limited to three people with at least one expert observer. On June 22, 2021, three groups of volunteers carried out the survey, each group visiting a different set of sites (Figure 4). Data from survey point P1 was collected on June 29, as this station was accidentally missed on June 22, 2021. The conditions on June 29, 2021 remained similar and within the timeframe for surveying that had been used in past years. Each group was led by an expert ornithologist and followed the method described below:

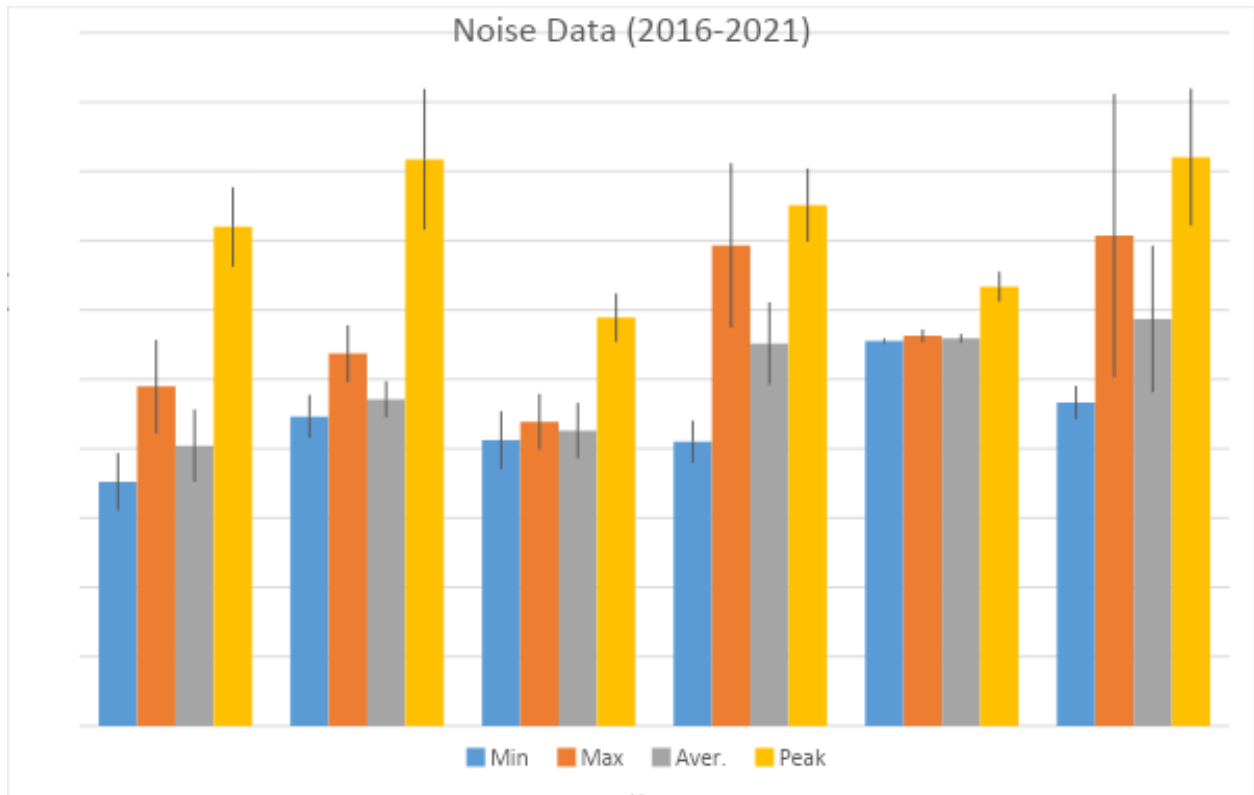
The sound level data is not homoscedastic, therefore a non-parametric analysis was performed. A Kruskal-Wallis test identifies that all sound parameters (average, minimum, maximum and peak) for different years have non-identical populations (Kruskal-Wallis rank sum test  $df = 5, p < 0.05$ ). Most of the sound parameters have their highest recordings after 2019 (Figure 6). 2017 is when construction noise was first recorded in the survey, and 2021 was the first noise data collected after the opening of the road.

Figure 6. Sound levels measured in the Weaselhead from 2016-2021. The error bars represent  $\pm$  standard deviation.

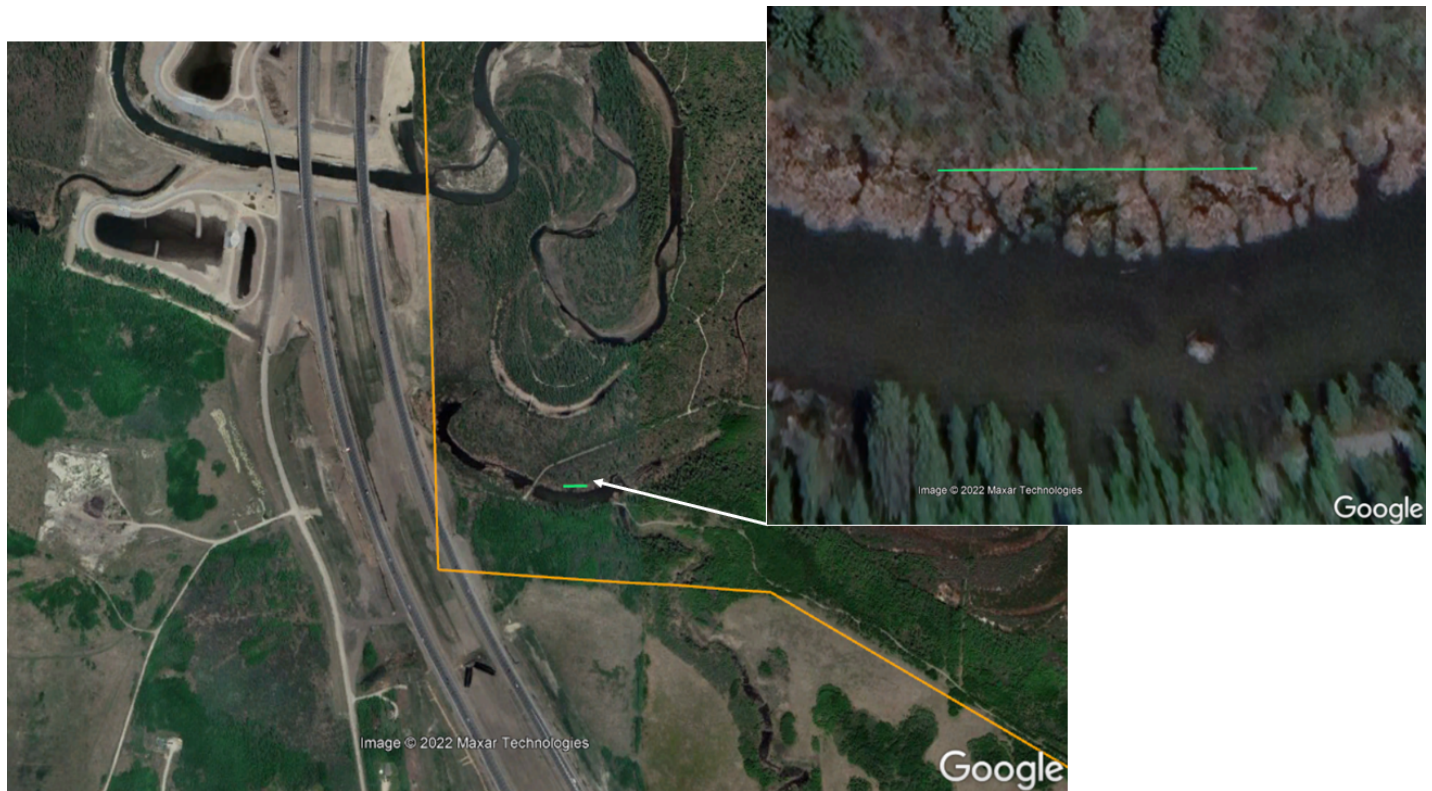
**Figure 7. Green line shows location of 50m transect used for vegetation survey on the north bank of the east Beaver Pond; orange line shows the Weaselhead boundary. (Aerial image from Google Earth, May 30, 2021).**

Baseline information was collected in 2015 and 2016 to describe the riparian vegetation by the Beaver Pond in the Weaselhead. This wetland was chosen as its upstream edge is bordered by the SWCRR and so represents riparian habitat in immediate proximity to the SWCRR (Figure 7). The results for 2021 are detailed below. The same site was used from 2015 to 2021. The same protocol was used as in 2015 to 2019. The assessments from the first 3 years included only flowering plants in the clade 'eudicot'. From 2018 on, estimates of % cover of graminoids and moss have been included as supplemental data. In 2019, 2020, and 2021 monocots in the orchid and lily families were found during the survey (and the title of the table of results amended to "vascular plants").

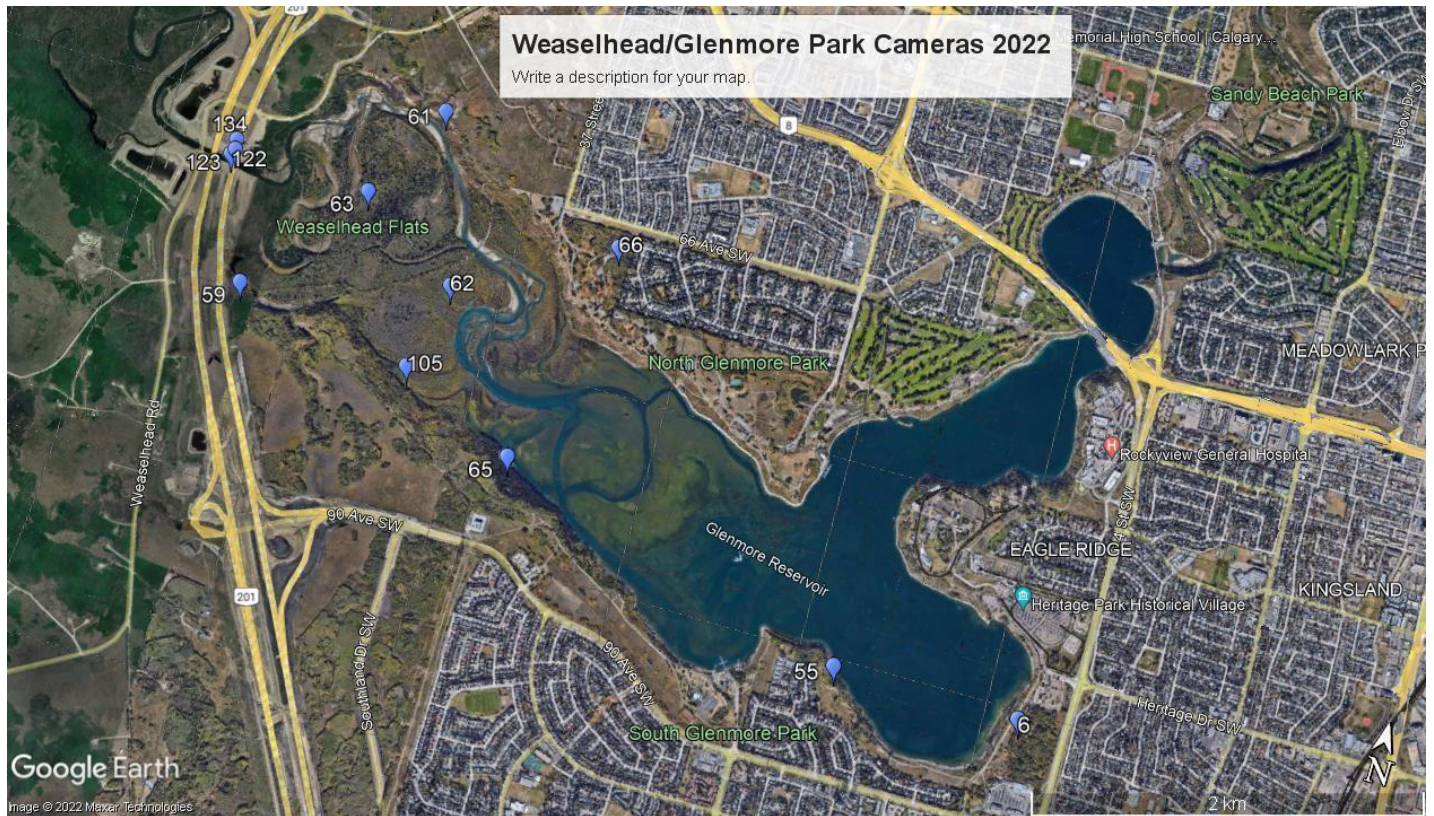
Figure 11. Location of 'Calgary Captured' cameras in 2021 (note – 2 cameras relocated under bridge in the wildlife corridor)

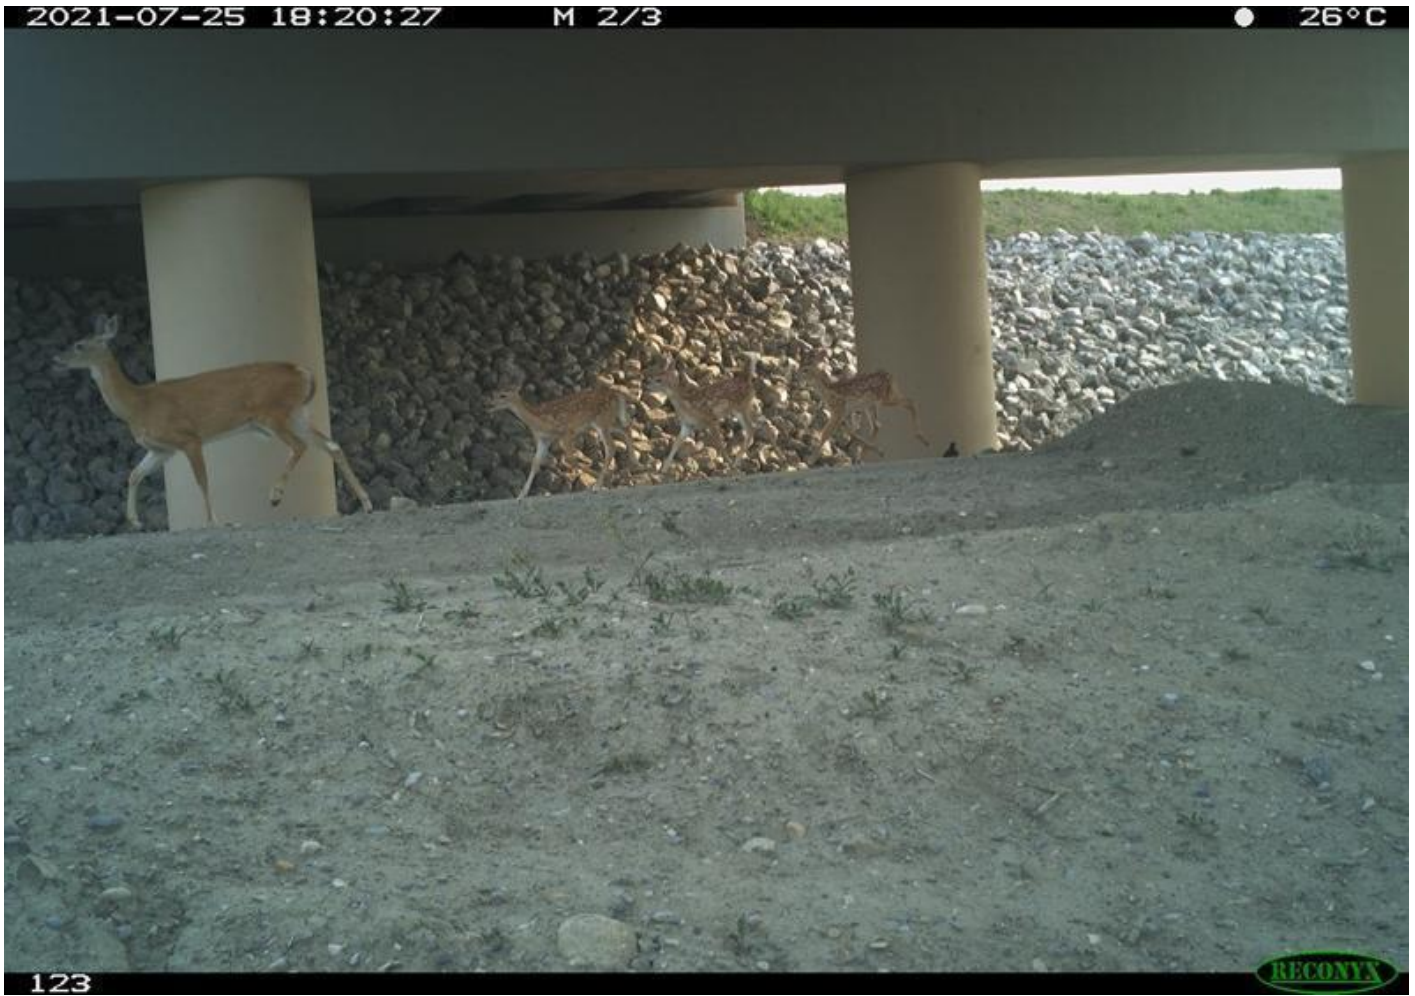
Figure 12. 'Calgary Captured' photo of deer under bridge in the wildlife corridor.

coyote) to the east and west of the Elbow River Crossing using the Buffer regions, but had limited evidence of corridor use (observation of tracks) under the bridges. Signs of animals under or between the bridges were much fewer than in the buffer regions though Calgary Capture cameras were able to confirm deer use under the bridges (Figure 12).

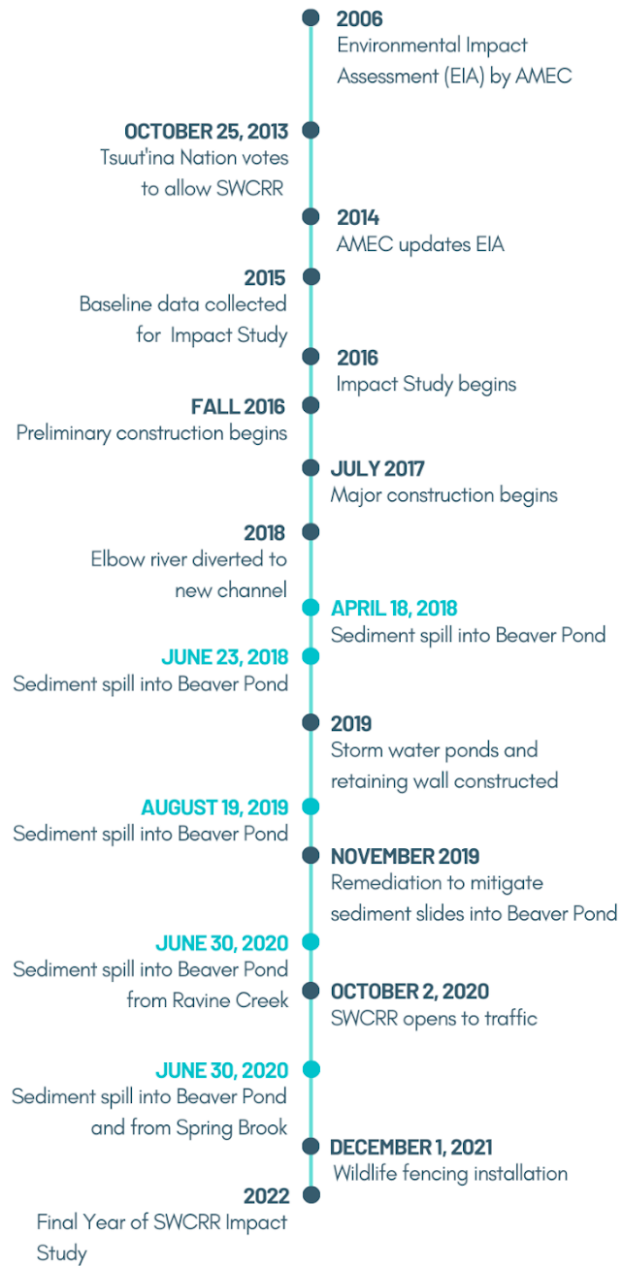
**Figure 13. Construction and sediment spill timeline**

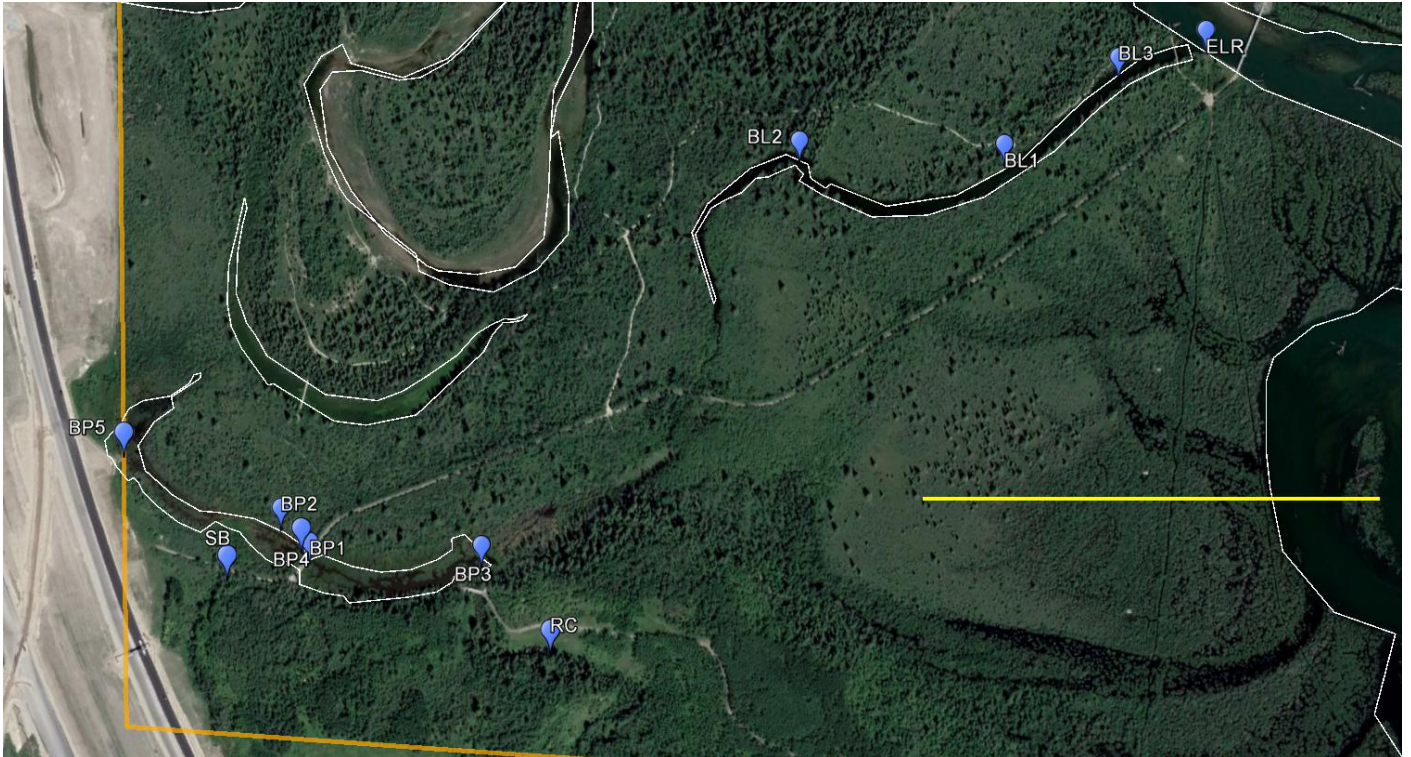
Figure 15. Location of sampling sites at the Beaver Pond (BP), Beaver Lagoon (BL), Spring Brook (SB), Ravine Creek (RC) and Elbow River (ELR); white lines show edges of permanent wetlands; scale: yellow line = 500m

Water quality data was collected from 2015 to 2021 from 3 sites in each of the three wetlands and from the Elbow River (Figures 15 and 16; Table 11). Four additional sample sites were added in 2018: another sample site in the east and west cells of the Beaver Pond (BP4 and BP5) and a sample site (SB and RC) in each of the two intermittent streams that flow into the wetland. Ravine Creek (RC) feeds into the east cell of the Beaver Pond (BP) and Spring Brook (SB) into the west cell. Both these streams have been impacted by construction of the SWCRR across their catchment areas (Figure 17).

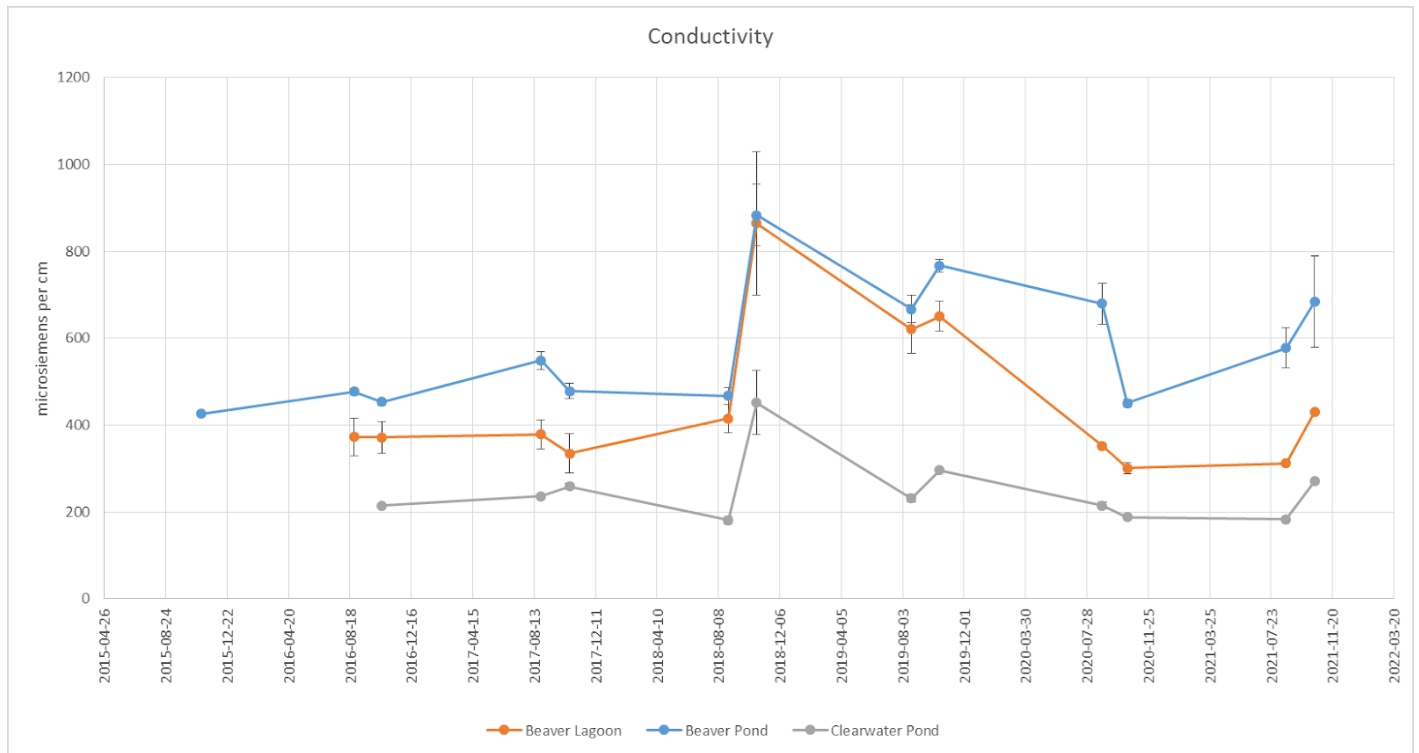
Conductivity fluctuations in the Beaver Pond between 2015 and 2021 shows the average conductivity levels were typically below 600  $\mu\text{S}/\text{cm}$  until 2018 when they peaked, and that averages in both wetlands have remained above 600  $\mu\text{S}/\text{cm}$  until summer 2020. A drop to values below 600  $\mu\text{S}/\text{cm}$  was observed in fall 2020.

In contrast, during this period the reference wetland upstream of the SWCRR development has shown no significant increase in conductivity.

**Figure 20. Conductivity recorded in the monitored habitats (Clearwater Pond (CP), Beaver Lagoon (BL) and Beaver Pond (BP)) between 2015 and 2021.**

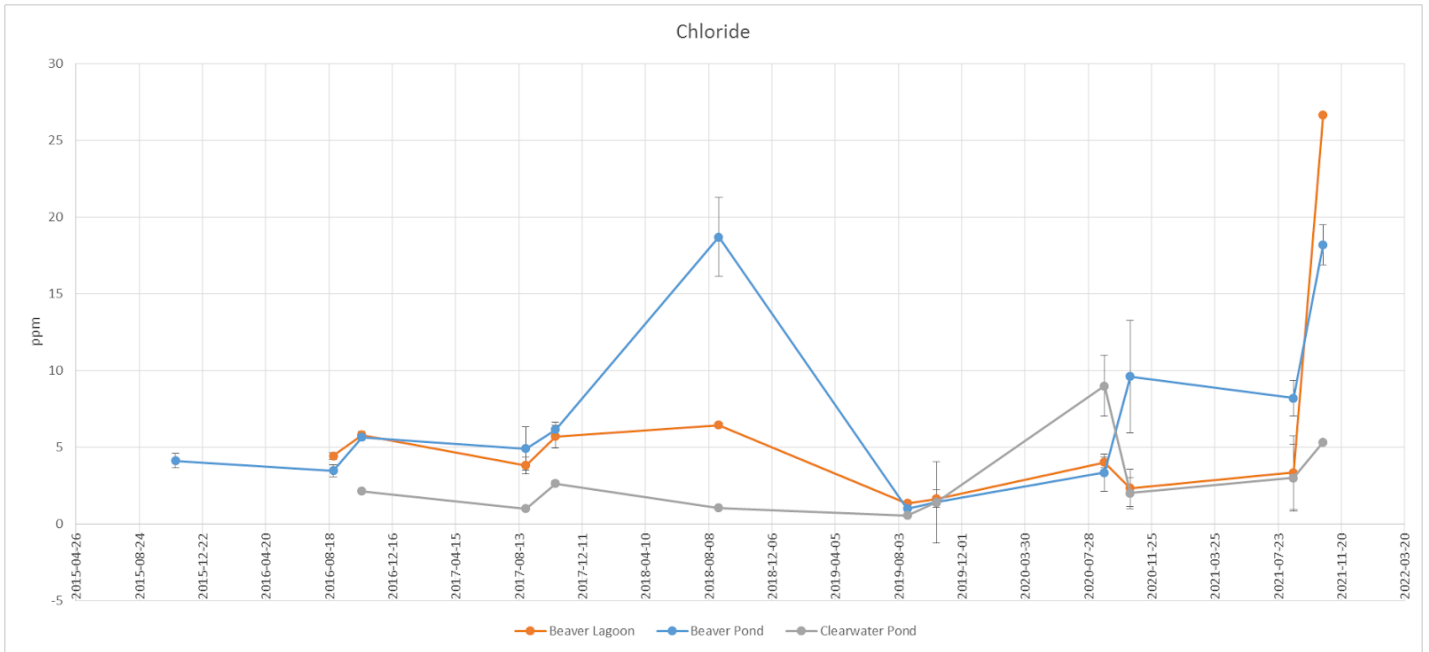
Similar to the results obtained for conductivity, regression analysis for the Beaver Pond for the period between 2015 and 2021 revealed a significant increase in chloride over time (linear regression, d.f.=44 (Beaver Pond),  $p < 0.05$ ). During the same period, the reference wetland (Clearwater Pond) and the Beaver Lagoon have not shown any association between chloride and time (linear regression,  $p > 0.05$ ). Data from 2018 are incomplete and were not used in the statistical hypothesis testing.

**Figure 22. Chloride recorded in the monitored habitats (Clearwater Pond (CP), Beaver Lagoon (BL) and Beaver Pond (BP) between 2015 and 2021.**

Regression analysis for the Beaver Pond for the period between 2015 and 2021 revealed a significant increase in chloride over time, as well as conductivity. The Beaver Lagoon had a noted increase in Chloride in 2021, however it has not yet been correlated to any pattern over time (Figure 22). As this was the first water quality testing since the opening of the road, this was expected, yet remains a disappointing reality related to road infrastructure in Alberta. The province is responsible for de-icing the roads and providing safe driving conditions. They use Calcium Chloride treated sand and Sodium Chloride (salt) as well as a mix of stockpile salt treated sand, depending on road conditions (<sup>18</sup>Alberta Transportation Website). The July 2021 spill into

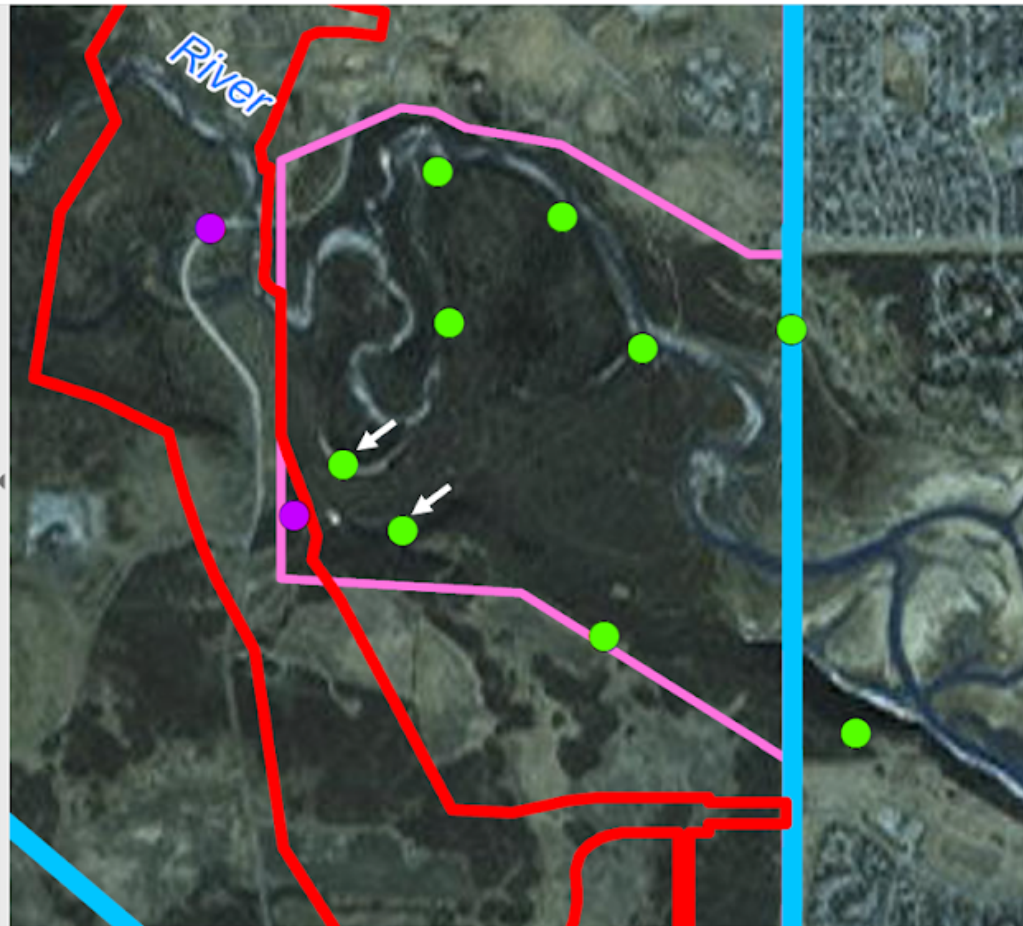
Figure 27. Locations of amphibian call surveys done in 2012 (green dots) and 2014 (purple dots) carried out for the EIA<sup>1</sup>. (red line = boundary of construction zone; pink line = boundary of park; (blue line significance unknown). The 2017 to 2020 monitoring sites are indicated by white arrows.

Nocturnal amphibian call surveys were done at two locations in the Weaselhead from 2017 to 2021. Only boreal chorus frogs, *Pseudacris maculata* and wood frogs, *Lithobates sylvaticus* were detected (Figure 27; Tables 21 and 22). The locations match two used in 2012 and are close to one used in 2014 for the EIA<sup>1</sup>. Surveys were carried out between 9pm and 11pm for 20 min. following a protocol developed by the Miistakis Institute for ‘Call of the Wetland’, a three-year study (2017 to 2019) into amphibians in the Calgary area. It is intended that at the completion of the 7 years of this study (2016 – 2022) results from the Weaselhead wetlands will be evaluated in the context of the results from this much larger study. Outcomes from this research<sup>14</sup> (Lee, T. et al. 2020) will help to decide if any changes in amphibian presence observed in the Weaselhead can be attributed to impacts associated with construction of the SWCRR, and guide potential restoration of movement corridors.

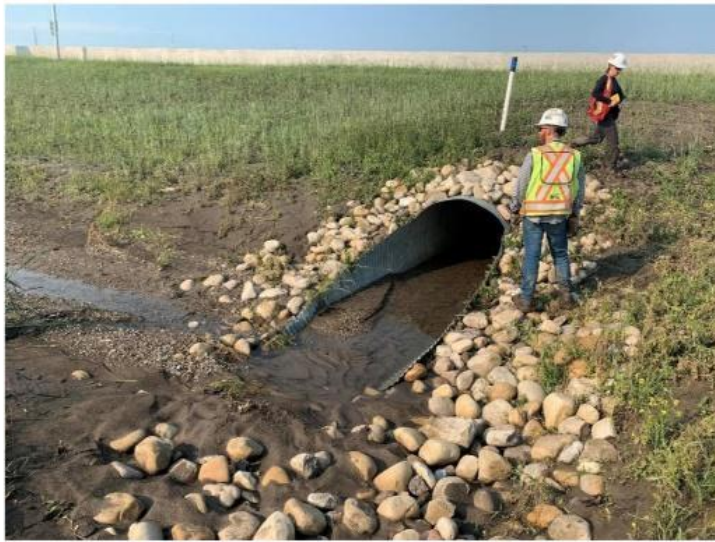
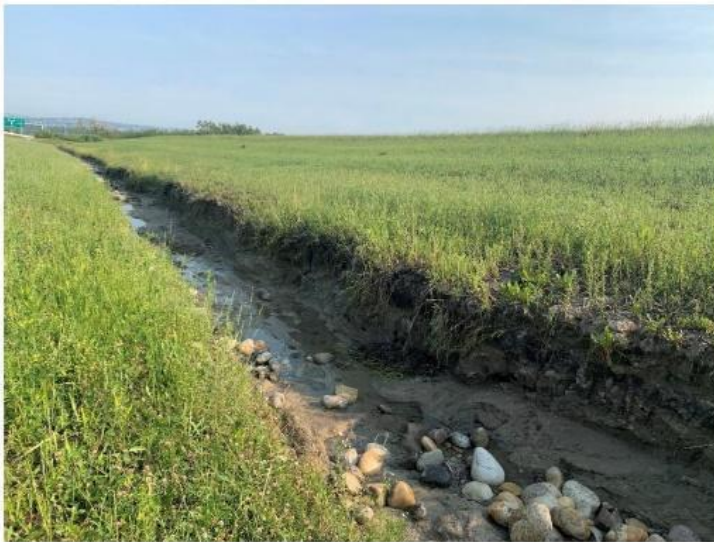
**Figure 28.** Silt inundation of culvert and ditch erosion after rain event. Taken from WAIR - Hemmera Inc.

On July 2, 2021, a major rain and hail event occurred, which is common in spring and summer, and was recorded by Environment Canada to have been 24.6mm of precipitation. This event resulted in an overwhelming volume of water running off the impermeable pavement surface of the ring road where it would have previously been absorbed by the former wetlands, forest, and meadow systems. The SWCRR design is intended to capture road runoff and direct it along a drainage system to the stormwater ponds for filtering before entering the river. This mitigation effort had not been completed to design specification when the rain event occurred, and major erosion of drainage channels occurred (Figure 28). The existing mitigation measures intended to direct runoff in the ditch through a culvert to the west side of the SWCRR (and from there to the stormwater ponds) also failed, resulting in a large amount of water with significant velocity running over a temporary berm and into Spring Brook, taking mixed and woody vegetative debris with it. The Beaver Pond, which Spring Brook feeds (Figure 16 to view the bypass drainage for Spring Brook) was heavily inundated with silty water, potentially carrying road contaminants. This event may have contributed to the increase in chloride and other pollutants found in the wetlands water quality assessments by both our Society and Hemmera Envirochem Inc. (<sup>10</sup>Wetland 06 Water Monitoring Report Southwest Calgary Ring Road Project). In addition the failure of the drainage systems resulted in the temporary closing of the SWCRR on July 2, 2021 as the road was overcome with water.

**Photo 7** Western culvert berm after rain event.

**Photo 5** Channel erosion within ditch alignment.

- Sediment accumulation within and around the surrounding inlet of the culvert indicated that culvert was likely compromised by sediment deposition and flow was impeded from being transported beneath the active roadway.
- Water accumulation within the holding pond and visual flow pathways (i.e., downed vegetation) indicated water overtopped the north portion of the holding pond and continued to flow to Wetland 06.
- Little to no sediment deposition was observed on the downed vegetation.

The Society recommends that KGL improve this design to ensure it is adequate given local hydrological data, and consider raising the berm height and armouring, as well as increasing the catchment space at the mouth of the culvert. Culverts appear too small to carry large volumes of water and may need upgrading. We also recommend replacing the sediment catchment pond located north of the berm in alignment with Alberta Erosion & Sediment Controls suggestion in their inspection report (<sup>17</sup>WAIR – Hemmera Envirochem Inc.).

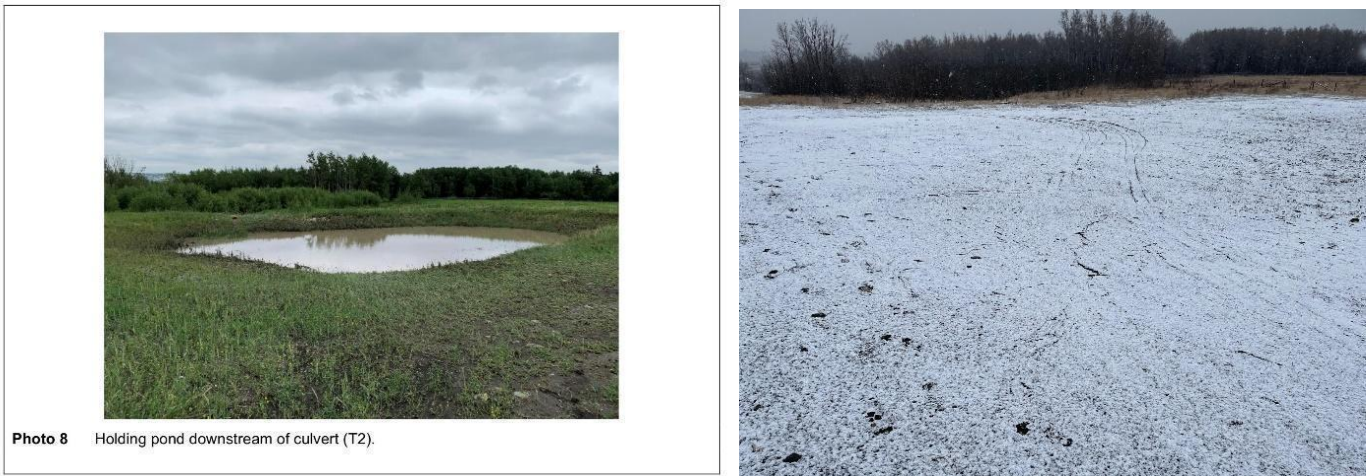
In addition to the drainage ditch and the temporary berm intended to direct the water to the culvert, an earlier temporary holding pond to capture runoff was overwhelmed in the rain event. This holding pond has since been filled in and at the time of writing this report in April 2022, now exists as a field of mud, as hydroseeding efforts appear to have failed in the drought over the 2021 summer and fall months.

Alberta Erosion & Sediment Control conducted an Inspection on July 8, 2021, and did suggest that a “possible storage pond will need to be constructed” and it is suggested in addition to the sediment catchment pond that existed at the time of the inspection (<sup>17</sup>WAIR – Hemmera Envirochem Inc.). The area poses a risk for significant increased turbidity in Spring Brook and the Beaver Pond should a major rain event happen and again overwhelm the berm and drainage measures (Figure 31).

**Figure 31. The holding pond after the rain event on July 2, 2021, while the adjacent photo taken on April 19, 2022 shows a large area of un-vegetated mud. Photo 8 from Hemmera’s WAIR.**

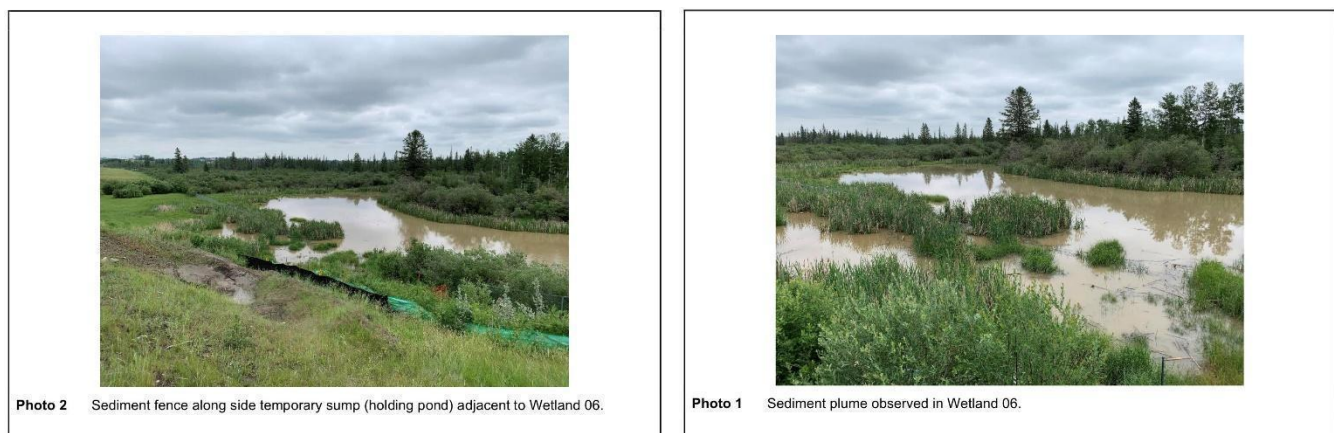
In addition to the Spring Brook flooding, another location on the west end of the Beaver Pond, where previous sediment spills have occurred, also had heavy erosion and some sediment deposits. The turbidity was recorded on July 5, 2021, in the Beaver Pond by Hemmera to be 102 NTU, in contrast to their regular measurements in Spring and Summer being 1.1 - 7.4 NTU (<sup>17</sup>WAIR – Hemmera Envirochem Inc.). In response to this, the catchment pond installed in November 2019 adjacent to the wetland was filled in and replaced with an erosion control installation on the slope. (Figure 32 and 33).

**Figure 32. View of Beaver Pond and increased turbidity on July 5, 2021 (WAIR - Hemmera Envirochem Inc.)**

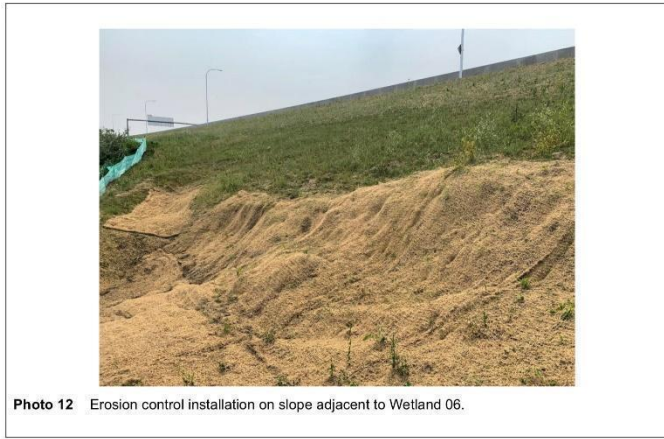
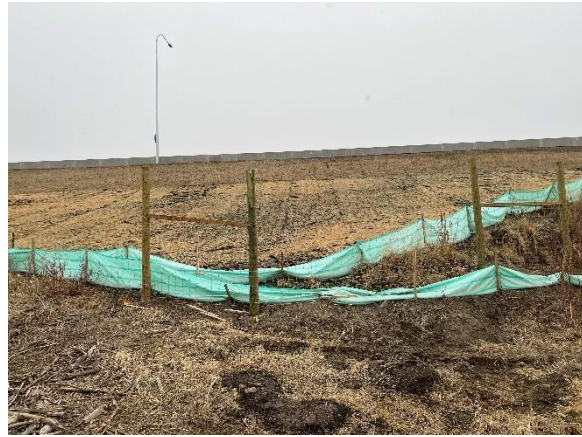
**Photo 12** Erosion control installation on slope adjacent to Wetland 06.

**Figure 33.** Hemmera WAIR photo 12 shows the installation of the erosion control matting in the summer of 2021. The following image was taken April 19, 2022 of the erosion control matting and fencing.

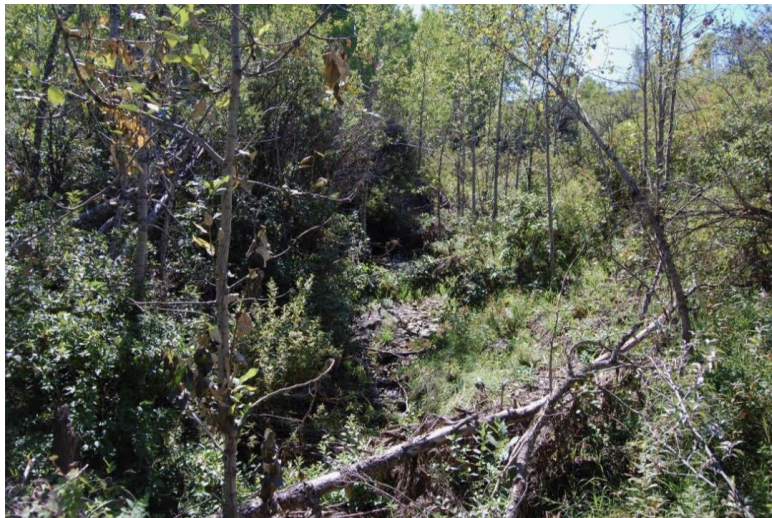
Our Spring Brook monitoring site (Figure 15) was dramatically altered from this flooding event as debris and trees are nearly blocking access to the site (Figure 32). Bank erosion was noted in the <sup>17</sup>WAIR – Hemmera Envirochem Inc. Fortunately it is still accessible, but drastically different and could result in stream shifts. However, the deep groove in the landscape which channels Spring Brook to the pond will help to maintain the location of the stream.

**Figure 34.** View of Spring Brook after the flood on September 6, 2021. Photo by Stewart Rood

It was expected that the ring road will influence a shift in runoff patterns due to the capacity of absorption being impeded by the pavement, however these results indicate significant changes beyond what was anticipated. Corrective actions were made by KGL after this event to improve mitigation. These actions included raising and improving the armouring of the culvert berm, repairing the heavily eroded drainage channel by recontouring to stabilize the ditch line, and applying erosion control blankets as well as reseeded. This work was completed July 30, 2021. Hemmera is optimistic that these efforts will be adequate and KGL will continue to monitor the remediation of this area until 2023. Because of the repeated failure of sediment and erosion control measures throughout this project, the Society believes it will be pertinent that these locations continue to be monitored and mitigation measures improved where necessary following any future mitigation failures.

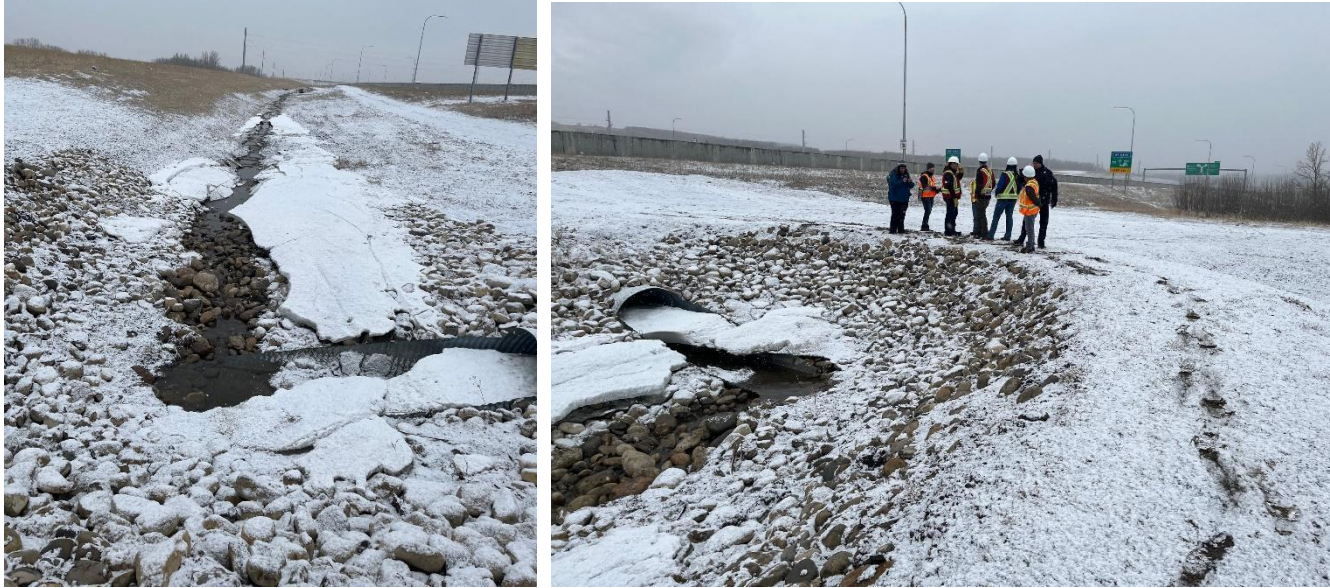
**Figure 35. April 19, 2022, visit to inspect drainage and stabilization improvements.**
