Weaselhead/Glenmore Park  
SWCRR Impact Study 2016-2022

**Environmental Monitoring Report 2021**  
birds, noise, vegetation, wildlife movement, water quality, aquatic invertebrates,  
amphibians, fish.

Author: Cassiano Porto, Lisa Dahlseide & Dylann Golbeck  
Calgary, May 2022

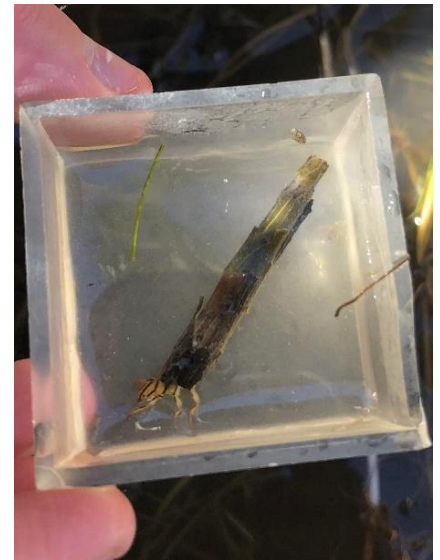
**Figure 36. Caddisfly larvae discovered September 7, 2021, in the Beaver Pond**

EPT represents pollution intolerant species of Ephemeroptera (mayflies), Plecoptera (stoneflies) and Trichoptera (caddisflies). While the regression analysis of data has not revealed any significant statistical association between EPT taxa richness % and time, we remained concerned about the absence of Caddisfly larvae found in the Beaver Pond. They were a species that consistently existed there prior to the construction sediment spills. On September 7, 2021, a group of students were conducting an educational pond study and discovered one individual caddisfly (Figure 36). This is a positive indication.

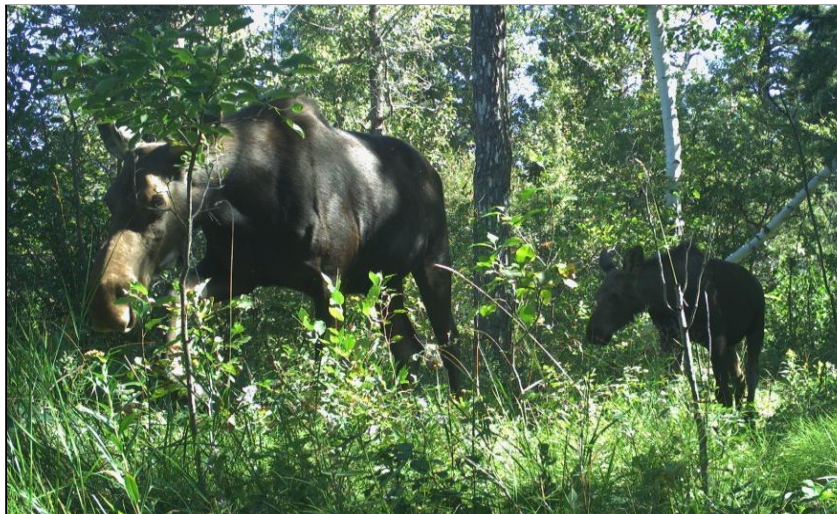
**Figure 37. Aug 2020. Two moose browsing caught on *Calgary Captured* camera #63, see Figure 11 for location.**

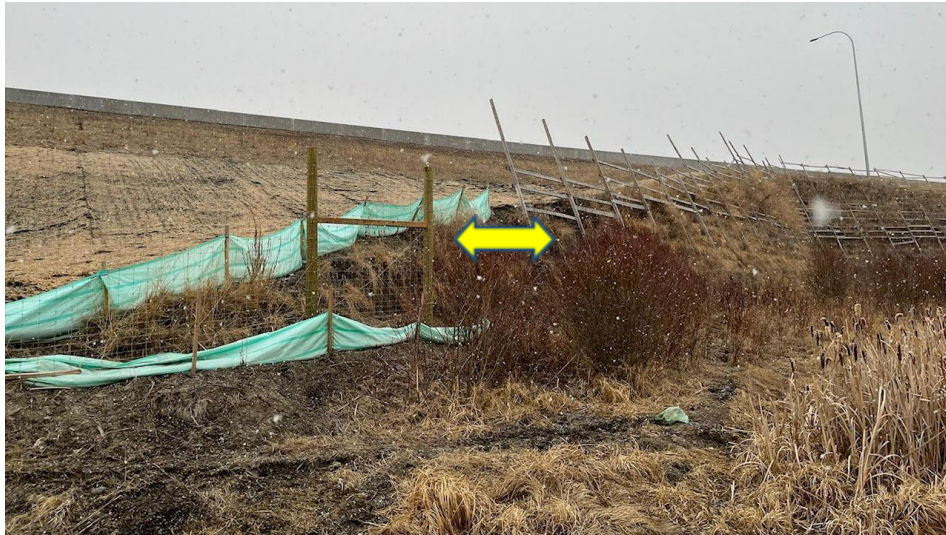
**Figure 38. West of the Beaver Pond and south of the retaining wall a visible gap exists highlighted by the yellow arrow.**

Another concern regarding the fencing is that the mesh used at the base does pose a significant risk for wildlife to get caught in it. Similar plastic, non-biodegradable meshes exist along the extent of the road and are trapped under sediment from the multiple sediment flows. All of these factors again pose a risk to wildlife getting caught in it. We recommend KGL remove it all or allow the Society to access the TUC to remove it. This work will require soil disturbance and efforts to reduce invasive plant establishment must be made.

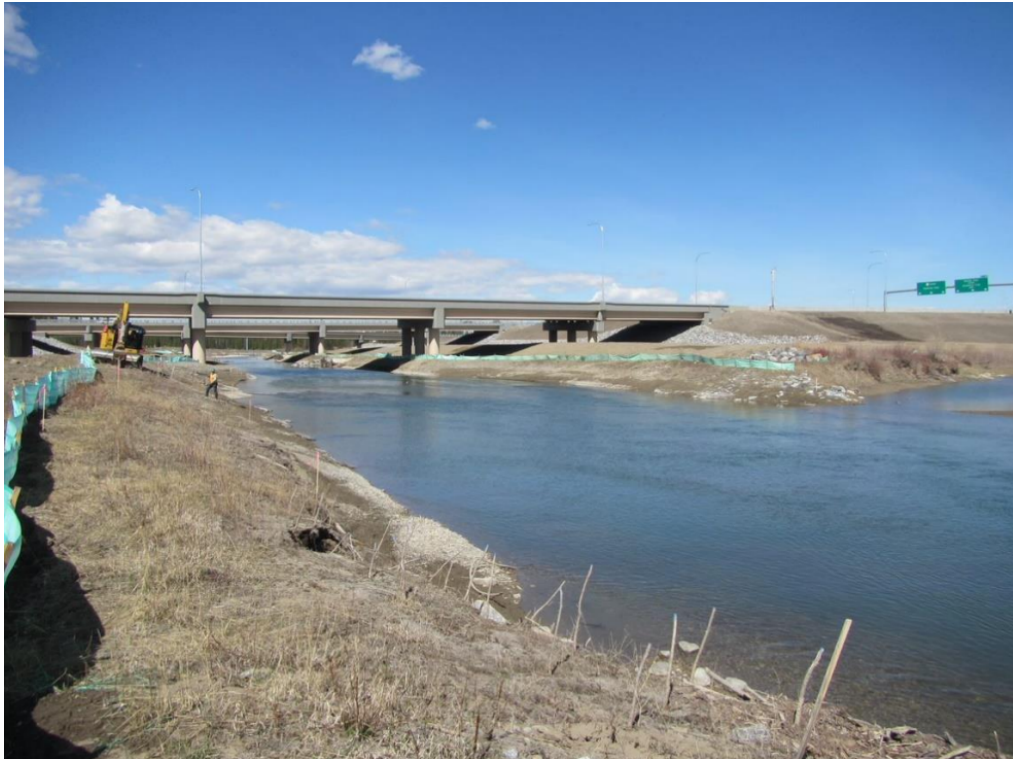
**Figure 39. View looking Northwest over the SWCRR showing the wildlife corridors in May 2021 showing construction using heavy equipment along the realignment corridor. Photo taken by Golder during the May 2021 track survey.**

Similarly, temporary fencing is still in place in a number of locations and appears to be buried under sediment from erosion in some of these locations as well (Figures 32, 33, 38, 39 and 40). It will be important to confirm that temporary erosion fences and other construction remnants are fully removed on project completion. A photo by Golder in June shows water levels facing east from the north bank of the river beside the bridge and temporary fencing in view on the south of the river.

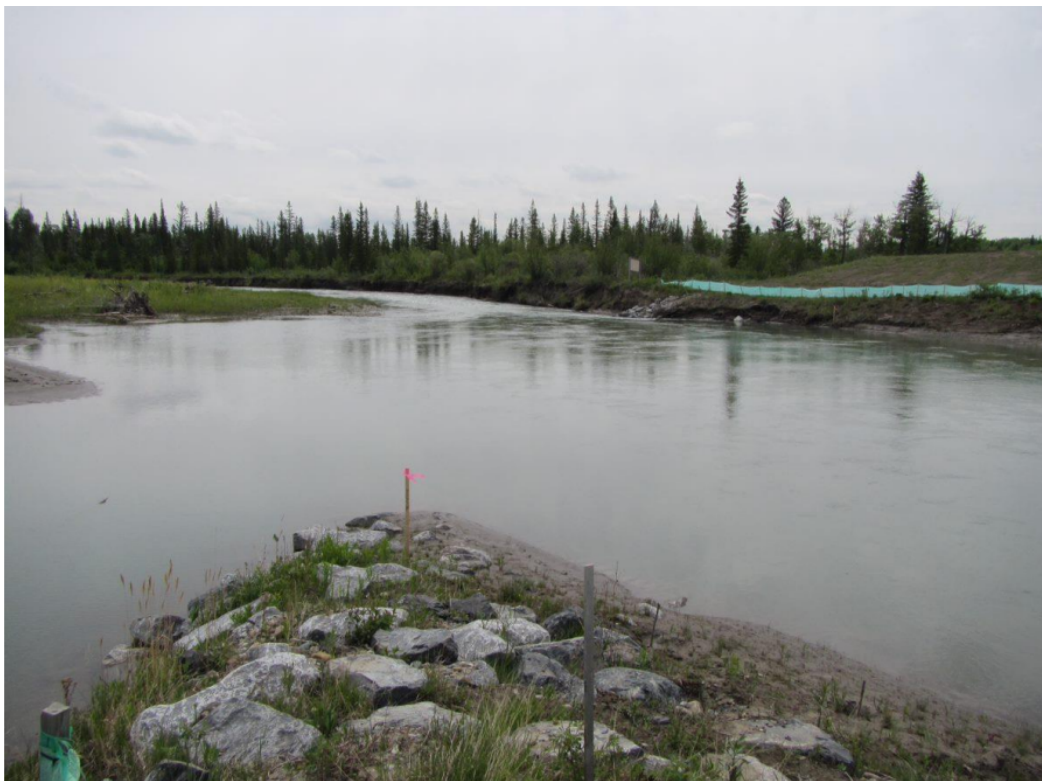
**Figure 40. View facing east from the north bank of the river showing water levels at the Elbow River realignment and temporary fencing on the south side of the river. Photo taken by Golder during the June 2021 track survey.**

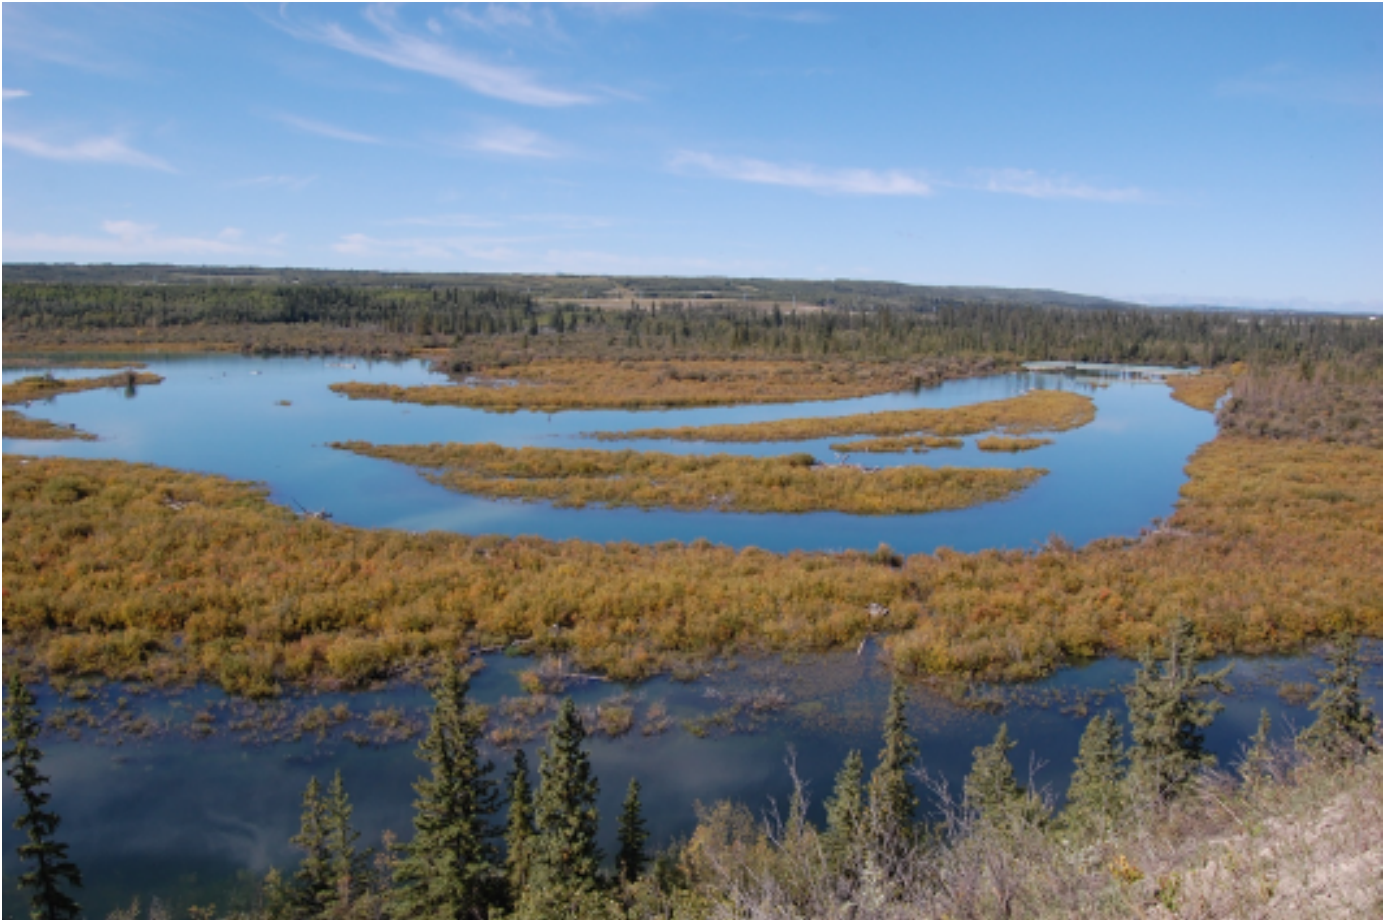
The City of Calgary improved the Glenmore Dam with restoration efforts completed by September 2020. Water levels were raised by 1.5m resulting in significant changes happening to the riparian vegetation and banks along the reservoir and Weaselhead Flats. This is an additional factor that will influence our aquatic invertebrate data due to terrestrial plants submerged at sample sites. The raised reservoir results in substantial flooding of the willow wetland on the Elbow River Delta (Figure 3). The inundation and especially submergence will probably result in mortality of the willows, dogwood and other riparian shrubs (Figure 42).

**Figure 42. A southwest-facing overlook of the Elbow River Delta in Weaselhead Flats, with the pathway bridge on the right.**

The delta includes an extensive and ecologically rich network of channels and islands that are covered with willows and other riparian shrubs. As part of the City of Calgary flood mitigation program, Glenmore Dam was raised, and Glenmore Reservoir displays greater fluctuation. The higher reservoir floods parts of the delta system and this will probably kill the willows in lower positions (Sept. 3 2021, Stewart Road). While these alterations are independent from the SWCRR Project, the timing is coincidental and there will probably be cumulative impacts from the roadway and reservoir projects.
